# Wildlife Movement Through Culverts and Bridges in Vermont: Influences of Structure and Site Characteristics

UVM Transportation Research  
Center  
National Wildlife Federation

Paul Marangelo  
Vermont Chapter

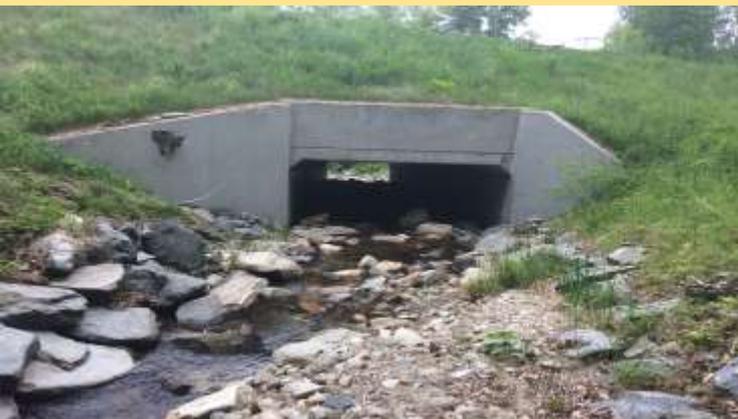
Large = New post-Irene pre-cast boxes

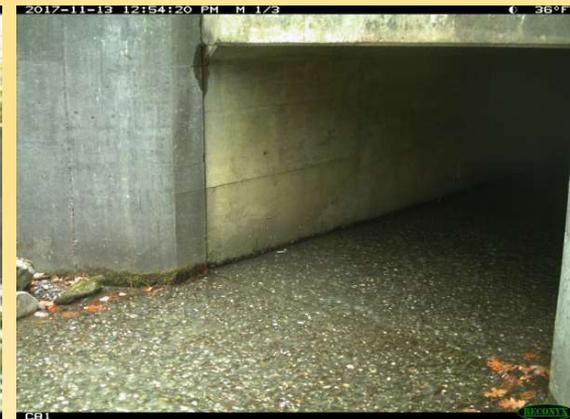
Small = older box culverts

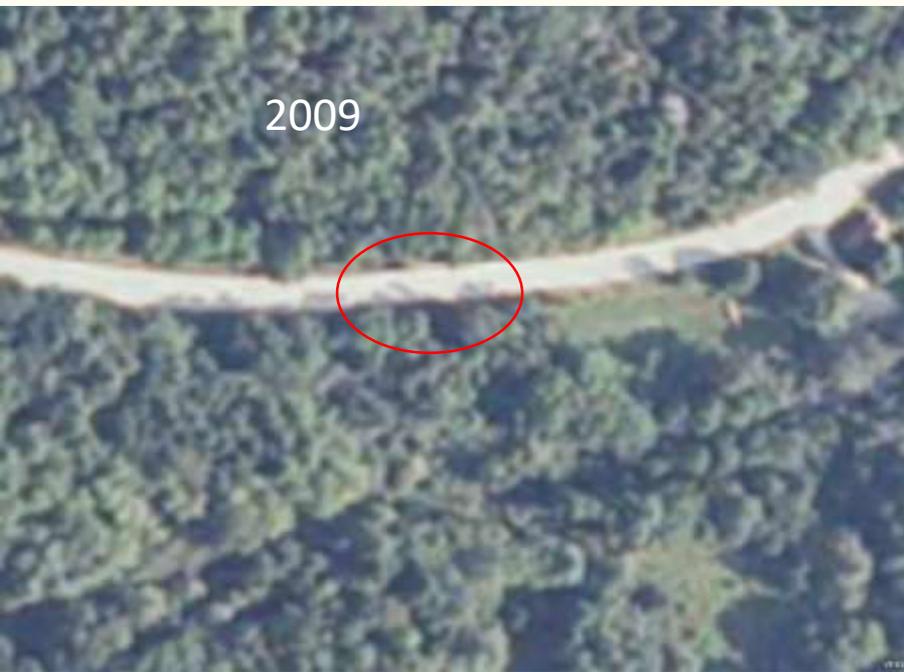
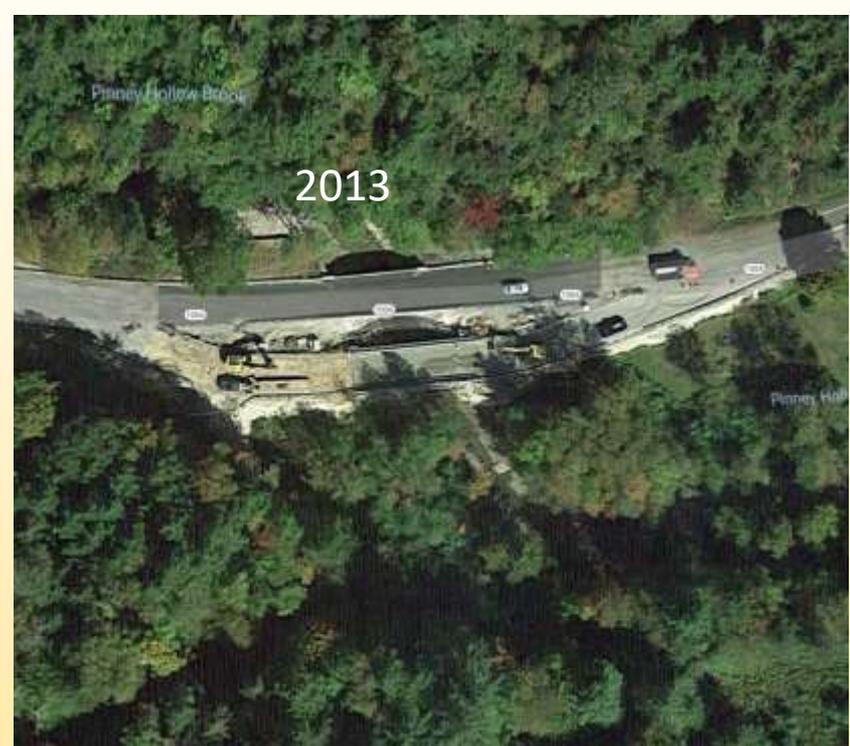
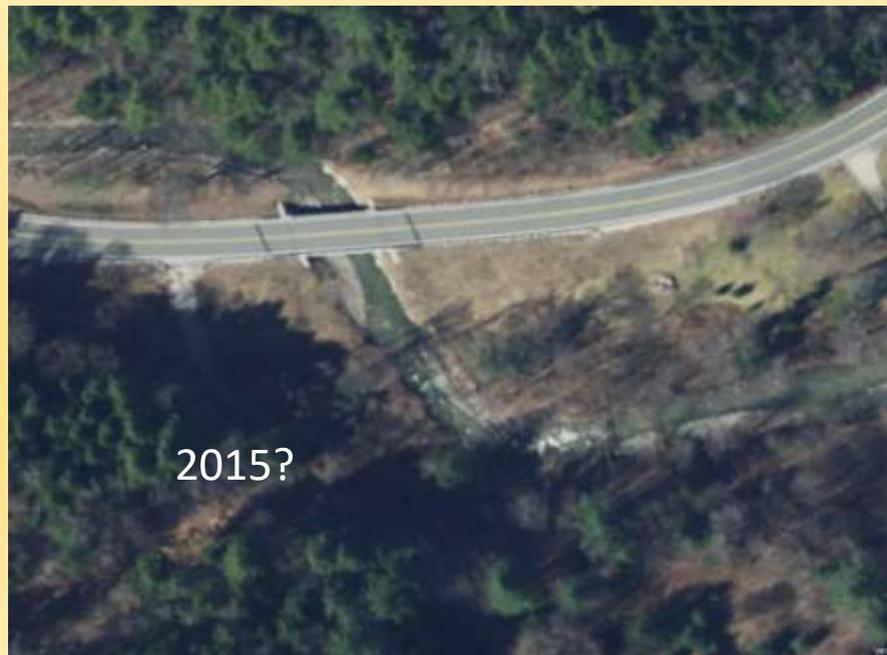
**Bridge 100a-8  
Plymouth, VT**

Construction footprint  
of temporary bridge

- Design features that maximize availability of dry “natural” movement surfaces in structures
  - Dry streambeds and even banks (right sized structure)
  - Grubbing over riprap banks (**bridge spans**)
- **Flat concrete bottom box culverts** don't perform well (best for weasels but bobcats prefer pipes)
- Replacements that use temporary bridges degrade site usefulness (large construction footprint)
  - Consider site restoration plantings

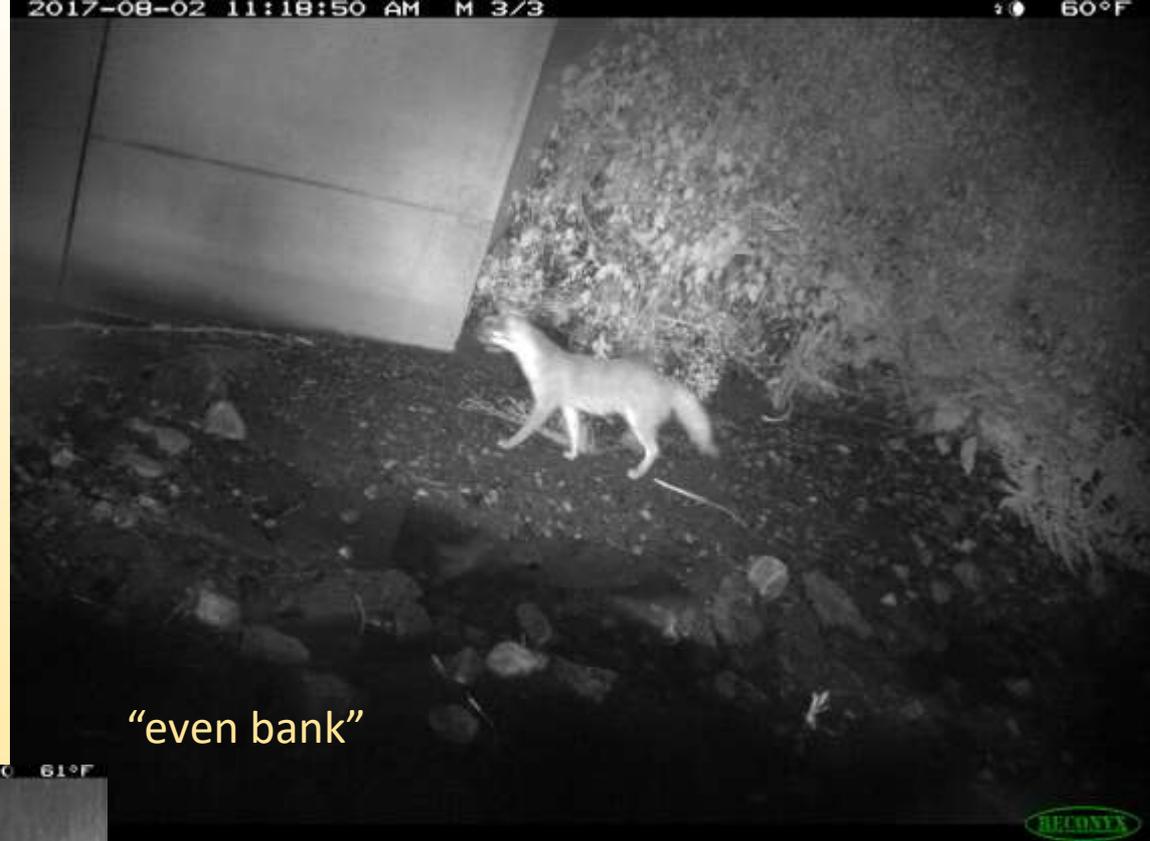
“even bank”

- Interior accumulation of substrate on top of concrete (“rock hop”)
- Large enough to allow for development of “even banks”

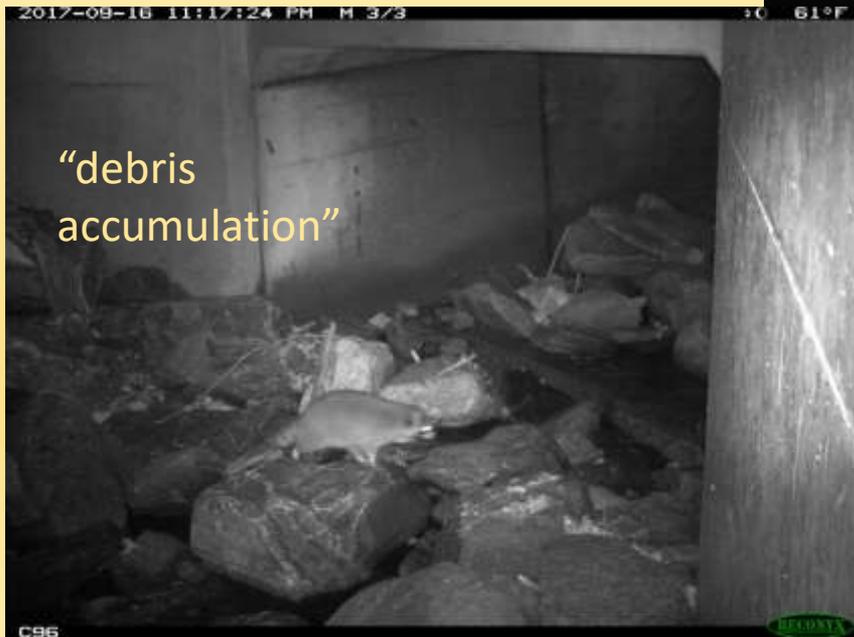
“debris accumulation”

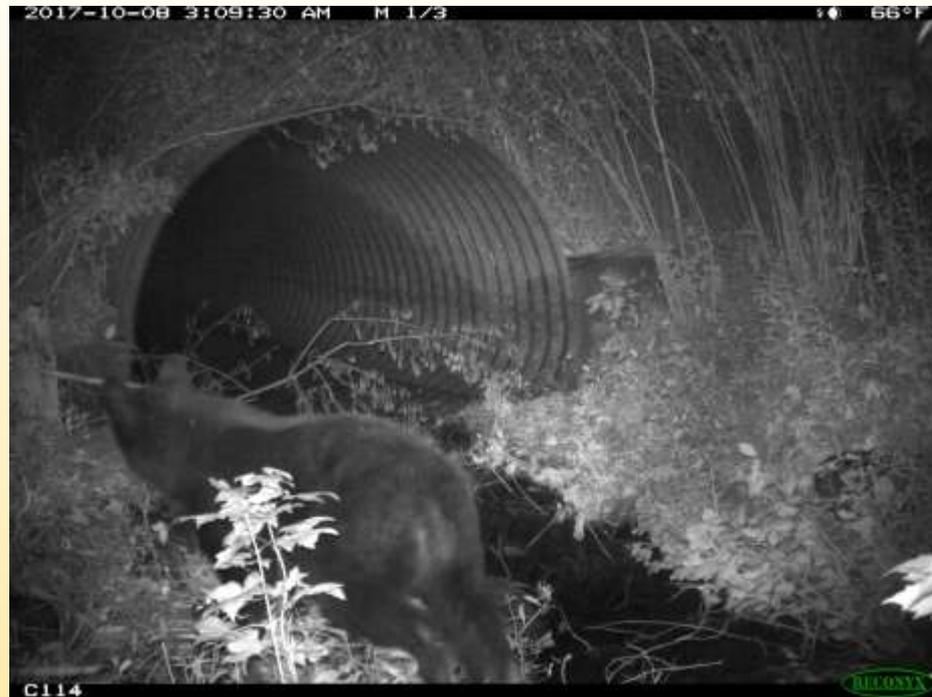
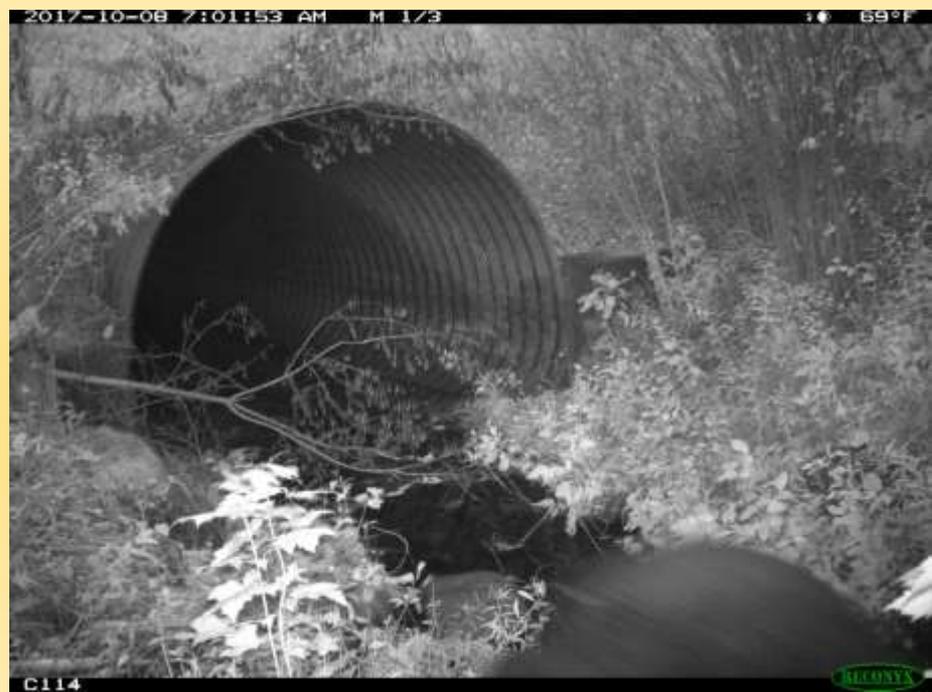
**Bear non-use:**

chooses road  
over squash  
pipe

4 hours between  
detections

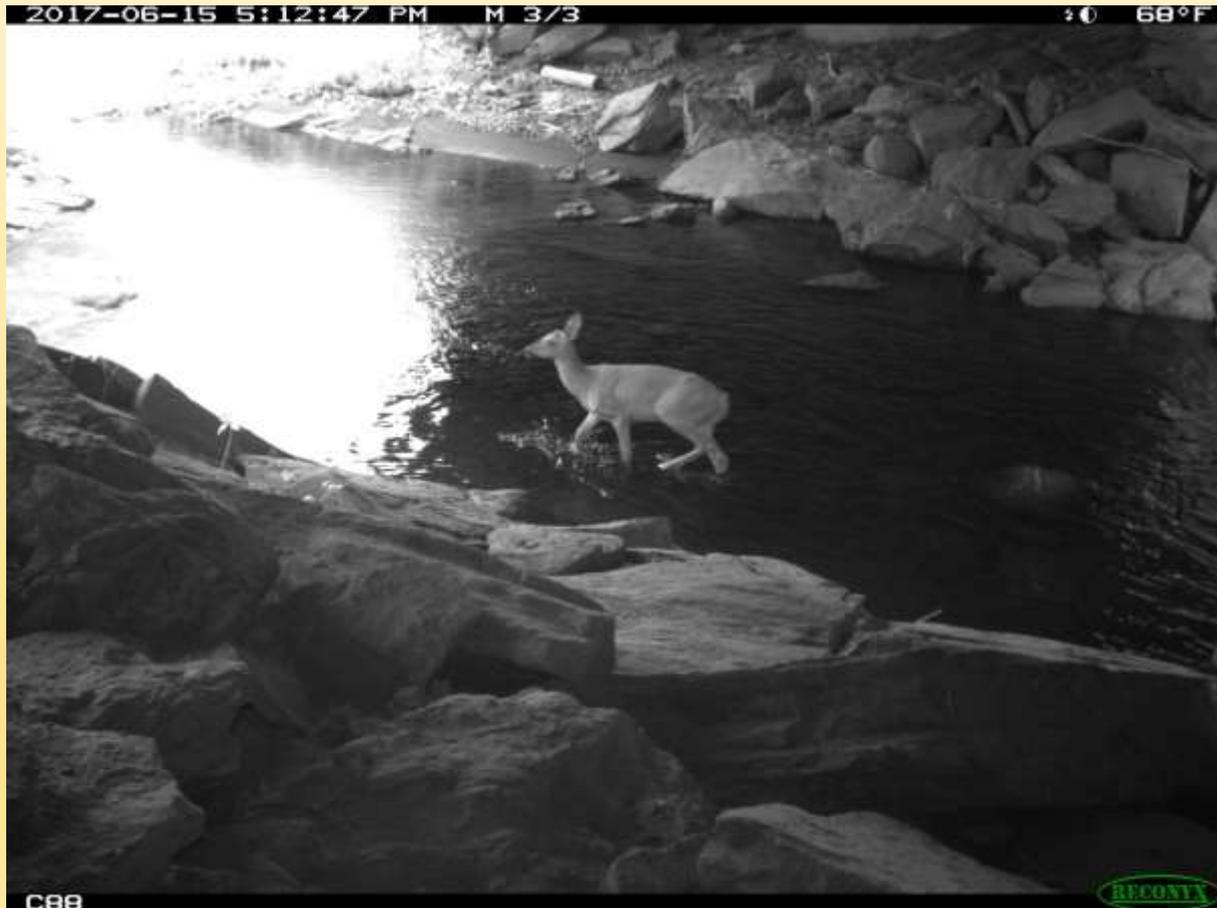
# Deer using a secondary movement surface VT 113 Vershire

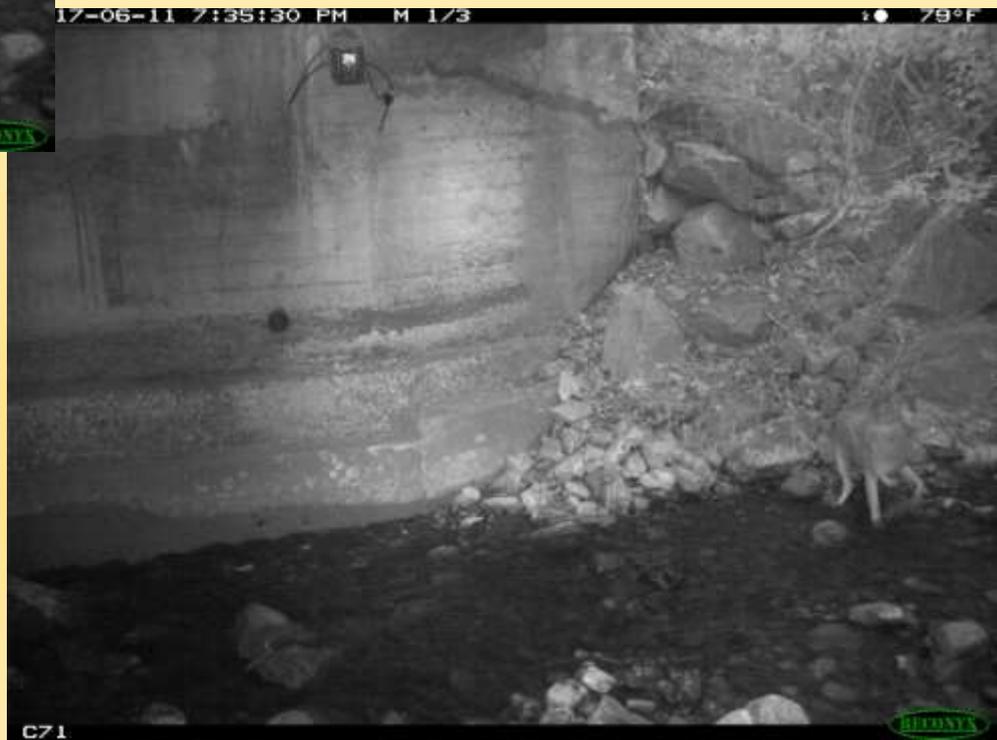
Coyote repel  
large span  
VT 133 Ira

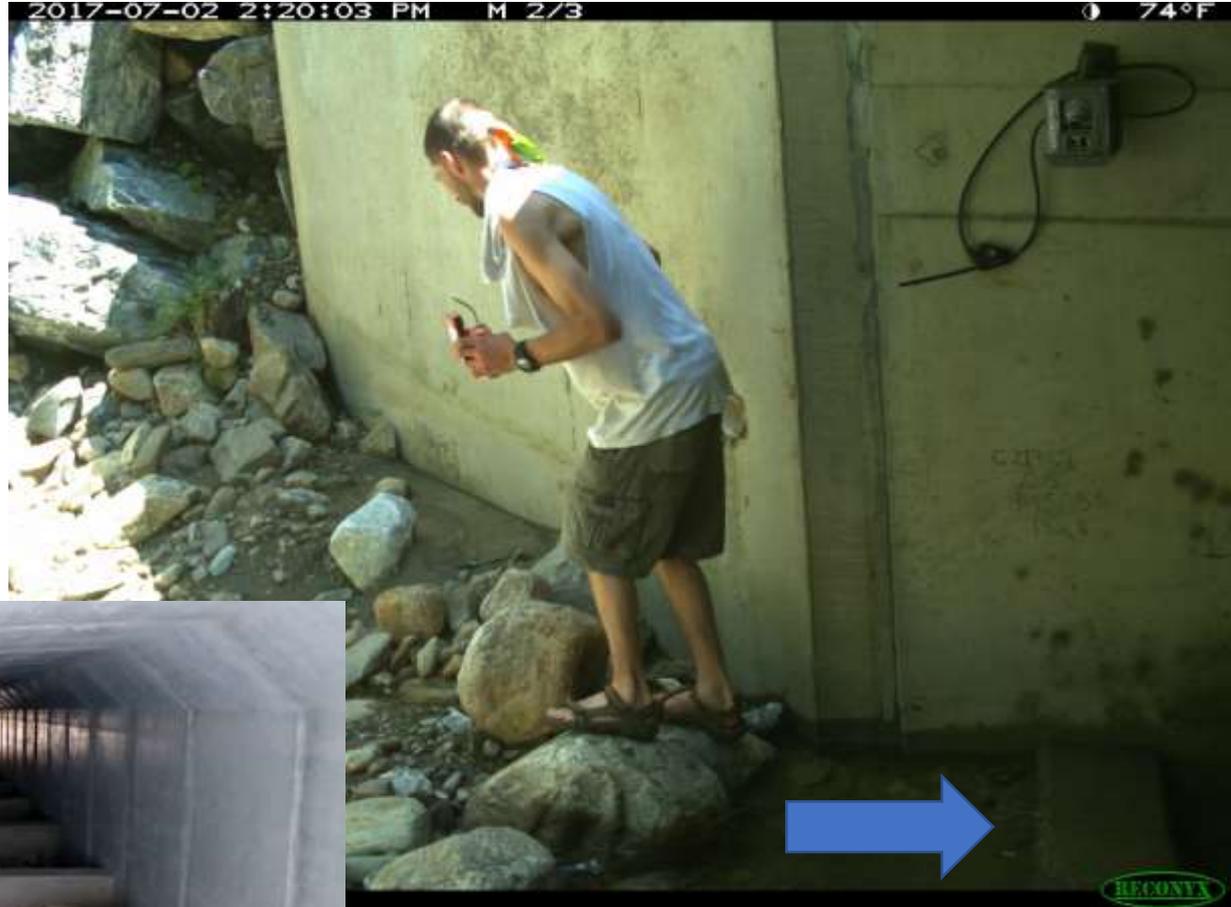
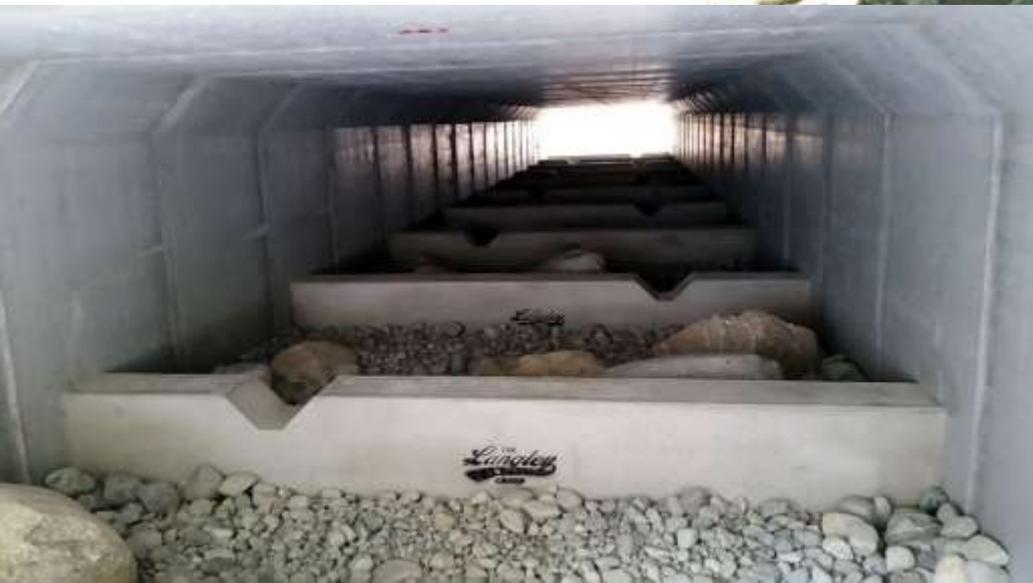
# Concrete baffles in high-gradient boxes

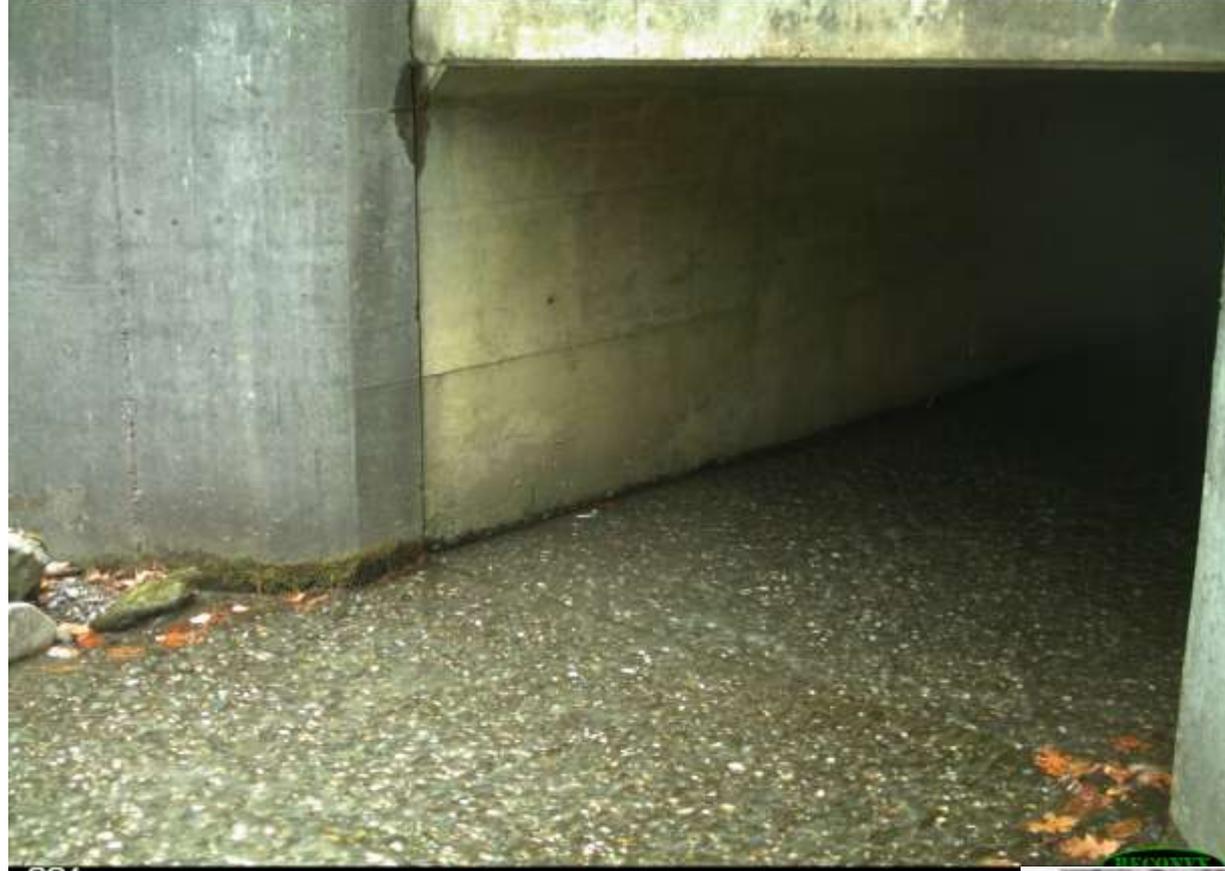
C81

30-22 West  
Townshend:

Pinched structural  
connectivity;  
under lots of road fill;  
no houses nearby;  
downstream west river  
flood control lands

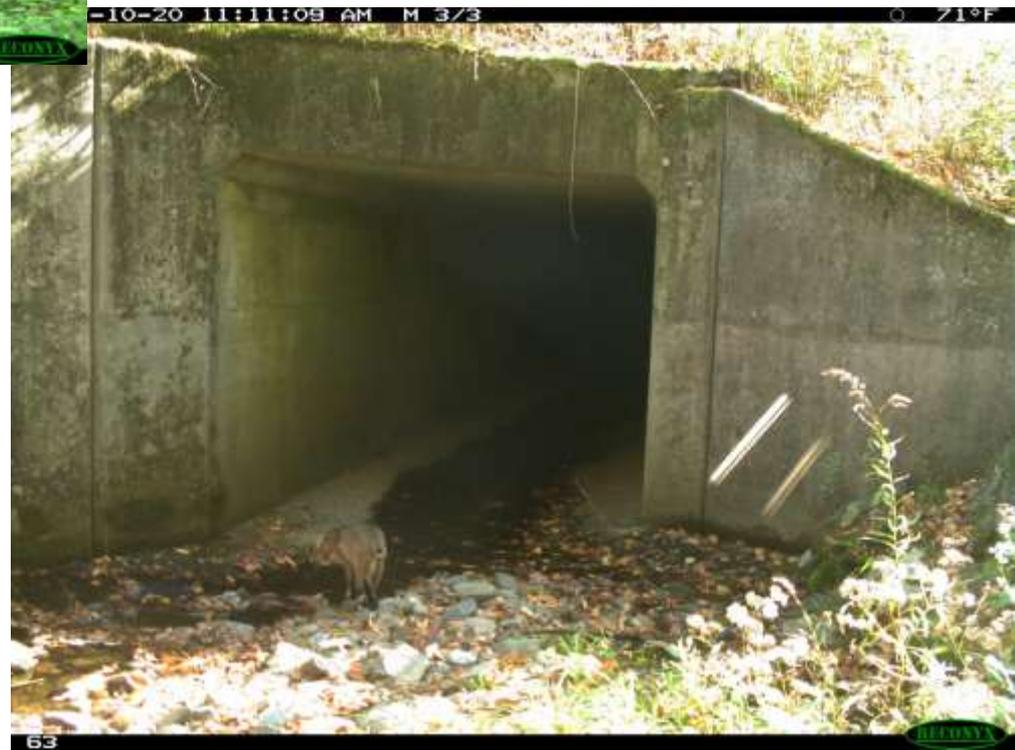
# I 91 – Putney: Rare “V” bottomed box culvert

- Interstate exclusion fencing funnels to culvert
- Poor downstream landscape context
- Too long (298 ft) for deer? Multiple detections/approaches, no passages

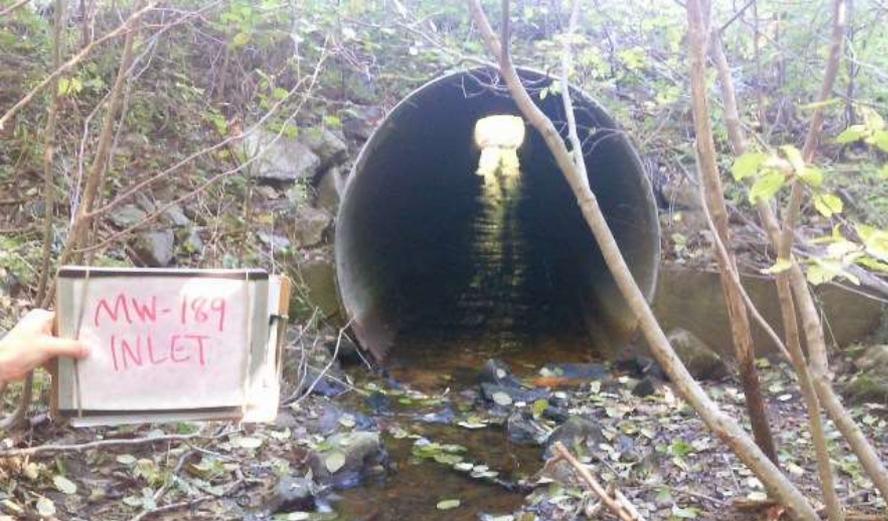
Site Landscape context  
fragmented;  
impassable  
downstream culvert
