# Assessment of Bat Roost Potential in New England Bridges

# New England Transportation Consortium Project 14-2

### NETC 14-2: "Investigation of Northern Long-Eared Bat Roosting Sites on Bridges" (2014) – Project motivation

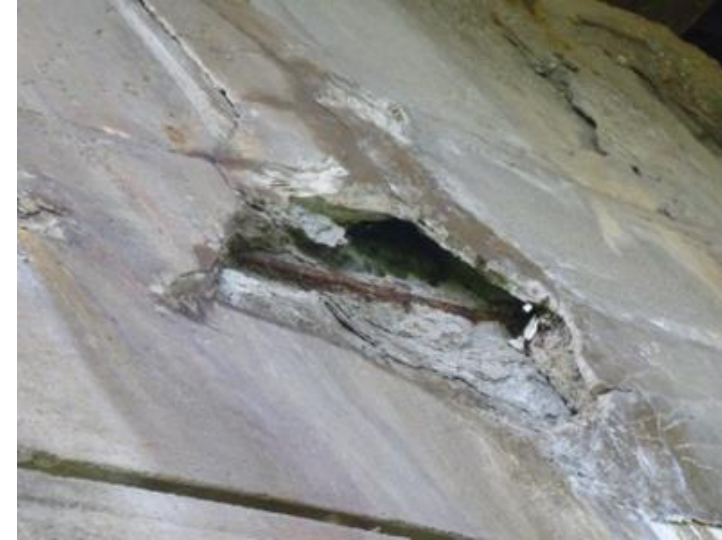
- Expansion joints
- Crevices between wood components
- Narrow spaces in high bridge beams
- Areas within pipe collars
- Areas behind/above insulation boards
- Cracks and spalls in concrete
- Cave-like environments
- Inside box girders
- Masonry cracks
- Cracks in abutments
- Fillets in precast girders

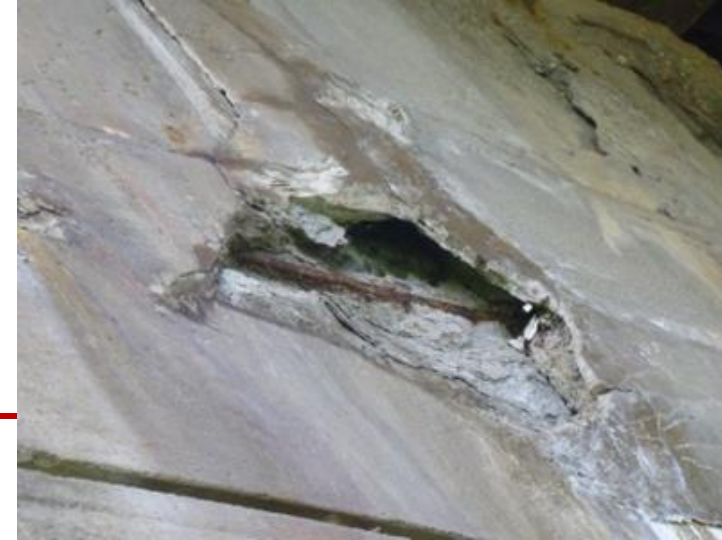
- Expansion joints
- Crevices between wood components
- Narrow spaces in high bridge beams
- Areas within pipe collars
- **Crevices 3/8" to 1-1/2" wide**
- Cracks and spalls in concrete
- Cave-like environments
- Inside box girders
- Masonry cracks
- Cracks in abutments
- Fillets in precast girders

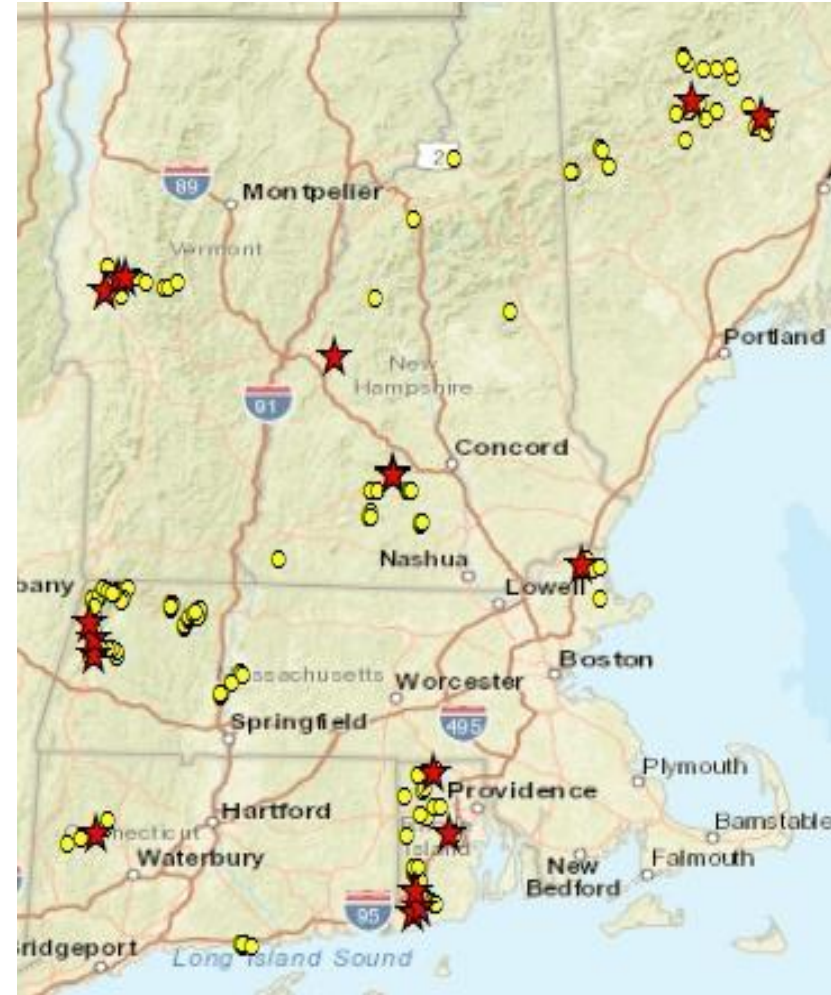
- Visual inspections and acoustic monitoring
  - Rapid visual screenings of 191 New England bridges (yellow dot)
  - Monitored 3 regions in New England
  - Detailed inspections, emergence studies, and acoustic monitoring of 18 selected bridges (red star)
  - Monitored early, mid, late seasons

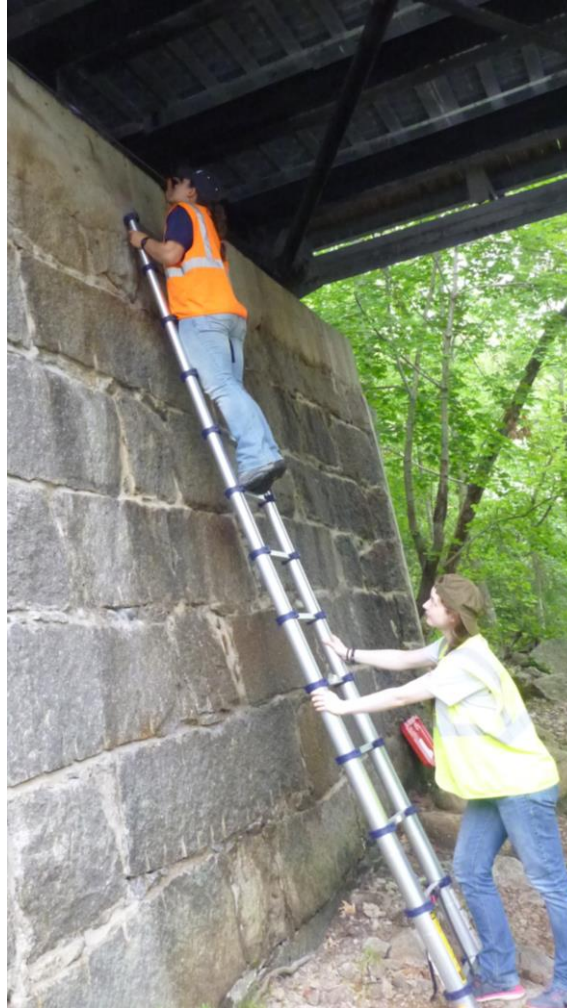
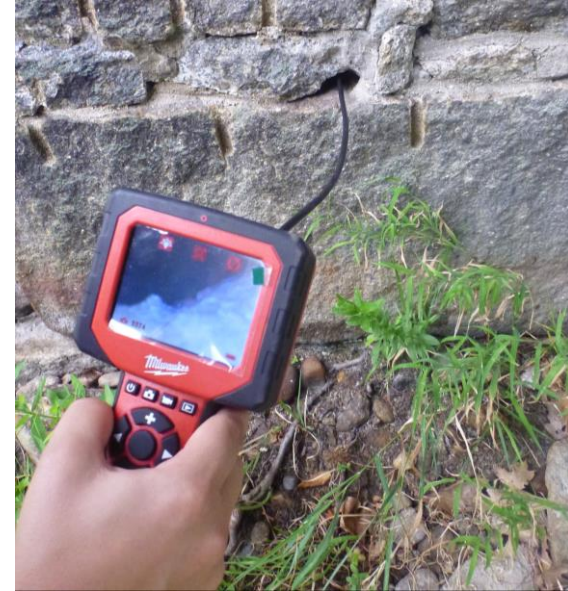
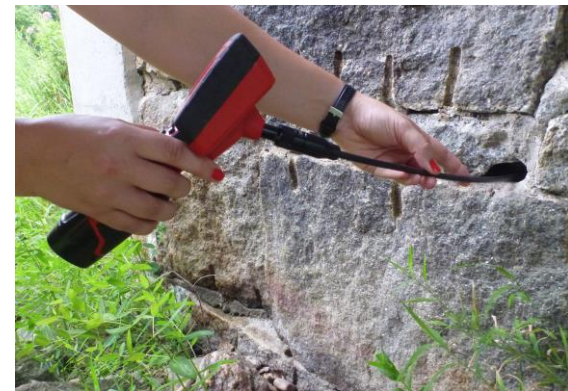
- More detailed inspections of 18 selected bridges
  - Inspecting all accessible locations
  - Ladder, waders, flashlight
  - Borescope use
  - Infrared thermal camera use

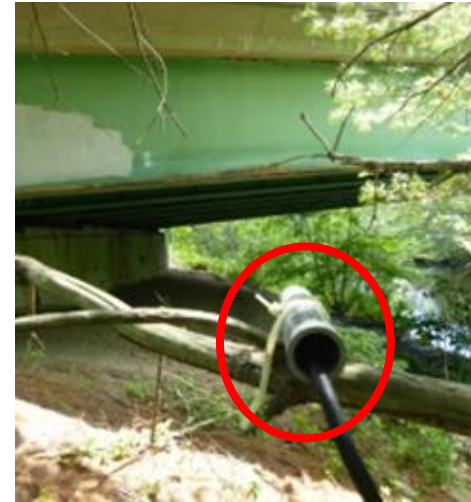
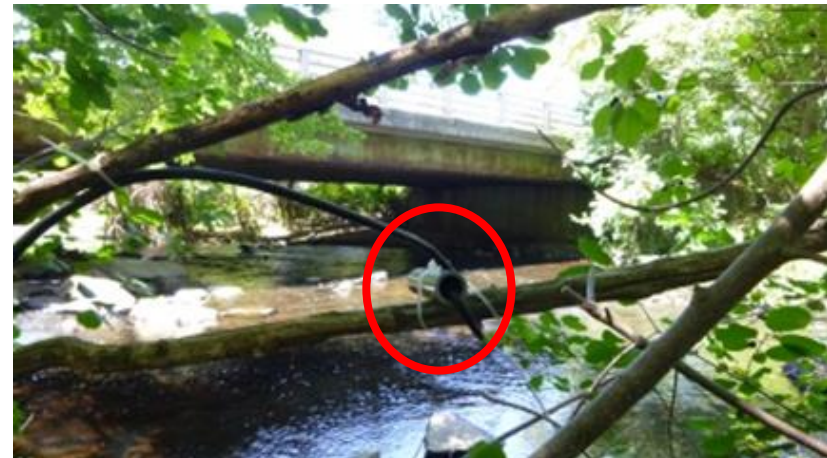
- Acoustic monitoring of 18 selected bridges summer 2015 through 2016
  - Pettersson D500X acoustic monitors
- Data analysis
  - Two automated acoustic bat identification software programs used
  - SonoBat and EchoClass

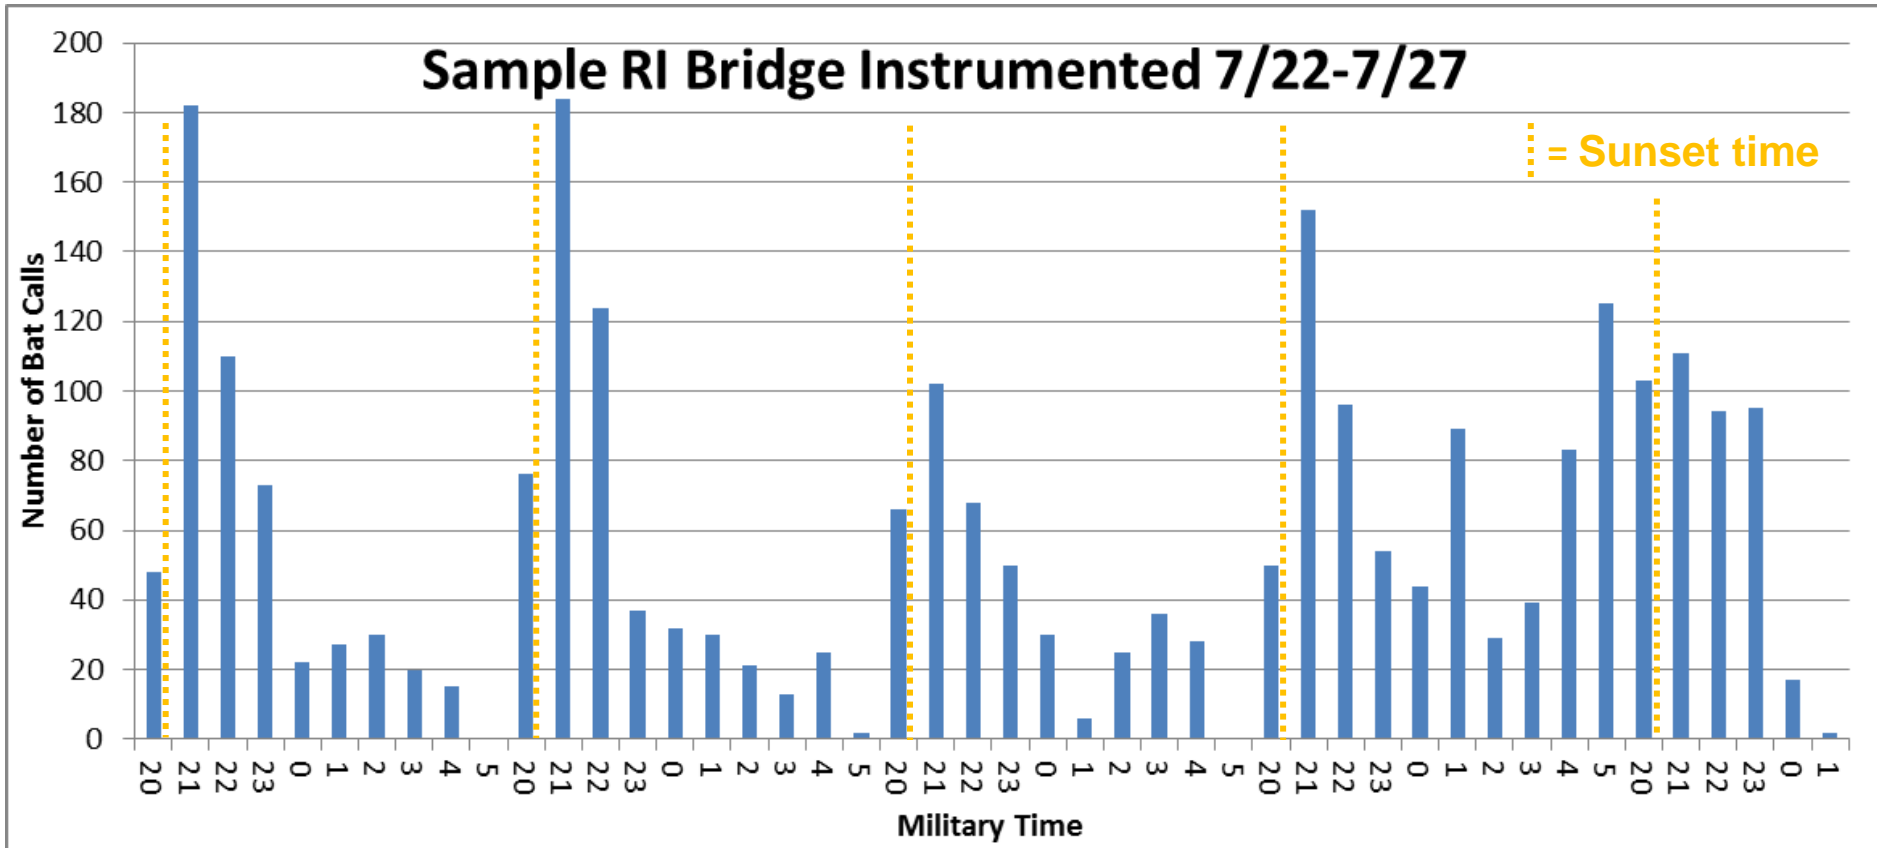
Figure showing bat calls recorded per hour

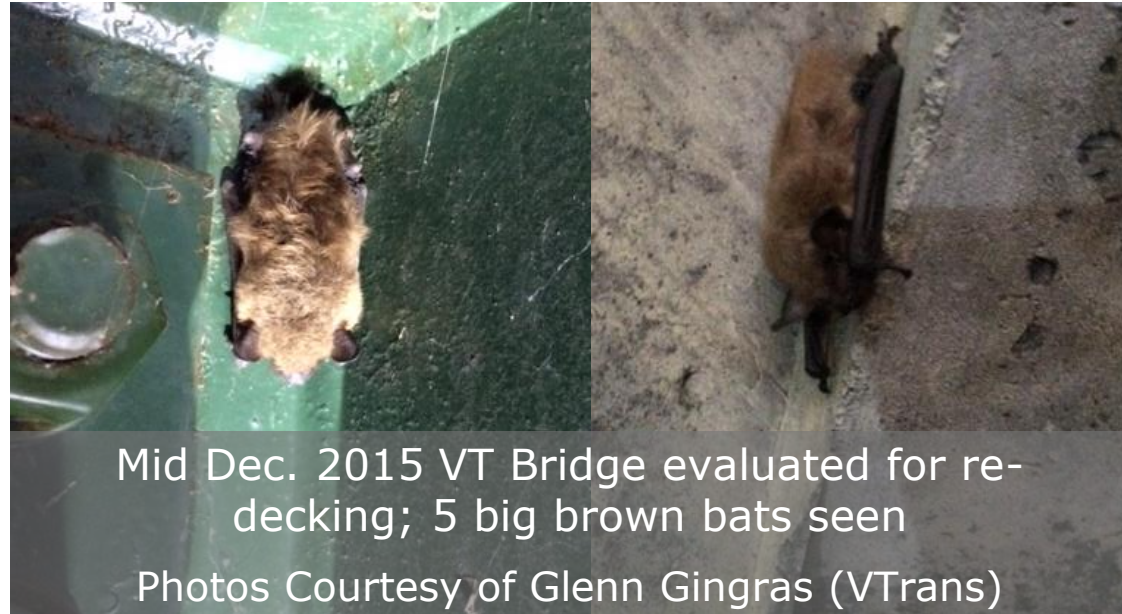
Maternity colony observed in VT bridge

Dead *Myotis* bat found under bridge near abutment

Bat observed in open roost at RI bridge

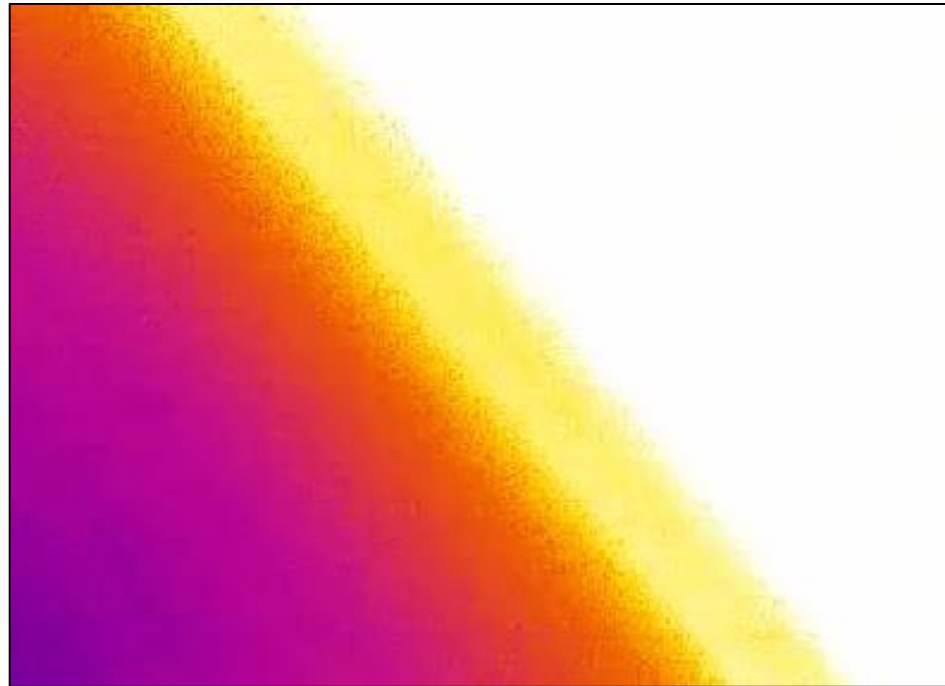
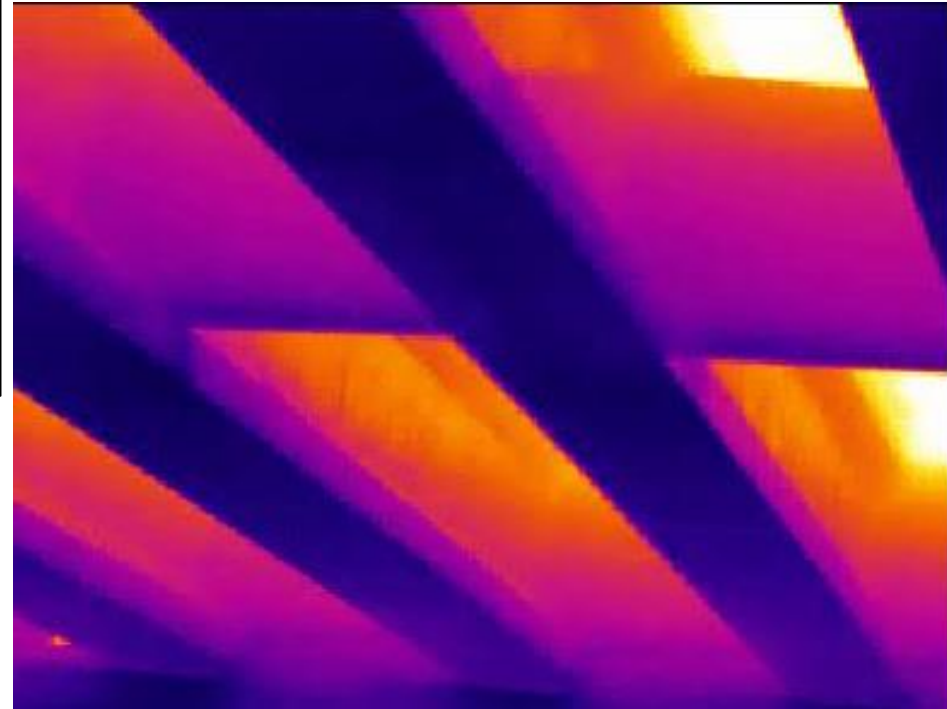
'Visual' Presence indicator  
captured through infrared  
imaging videos

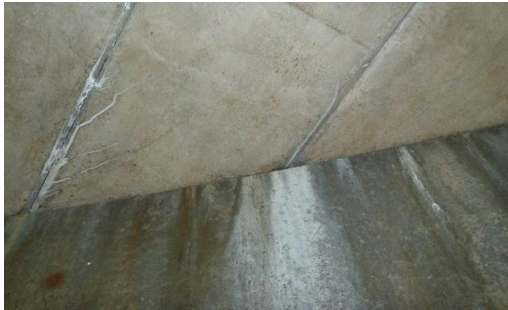
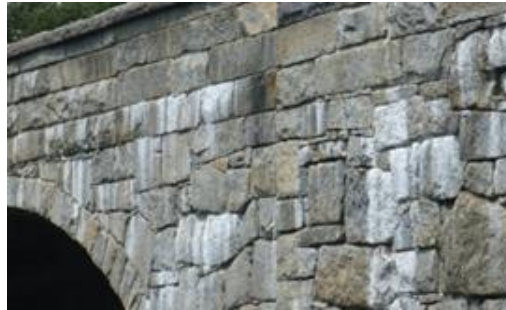
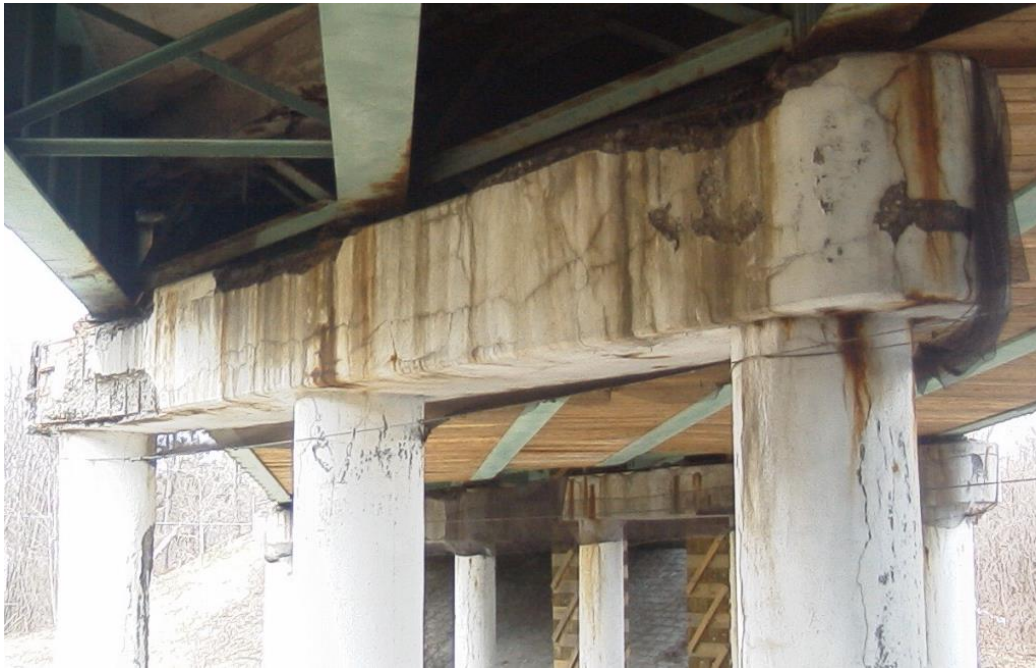
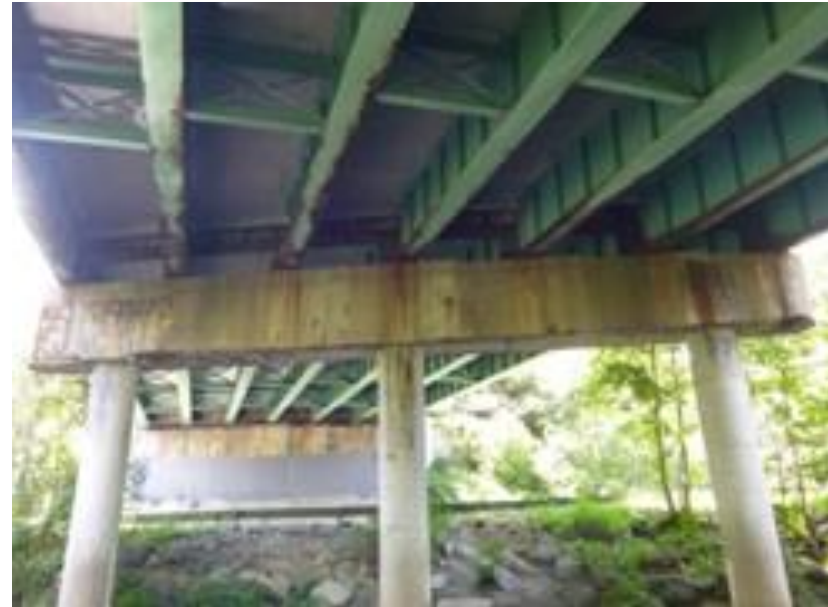
Staining from unspecified causation

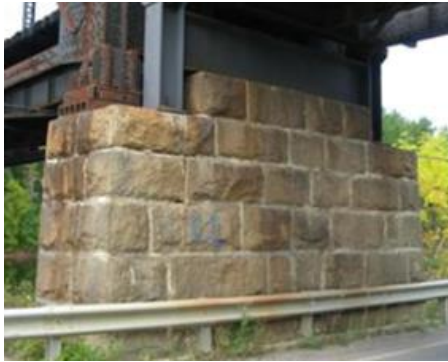
“Worker disturbed a large group of roosting bats – so many emerged from the crack that he took a break from his repair work to give them a chance to clear out of the roost.”
