Working with the NYSDOT to Implement Invasive Plant Prevention & Management Practices Along Adirondack Roads

**Brendan Quirion
Adirondack Park Invasive Plant Program
& The Nature Conservancy – Adirondack Chapter**

Best Prevention & Management Practices for Invasive Plants

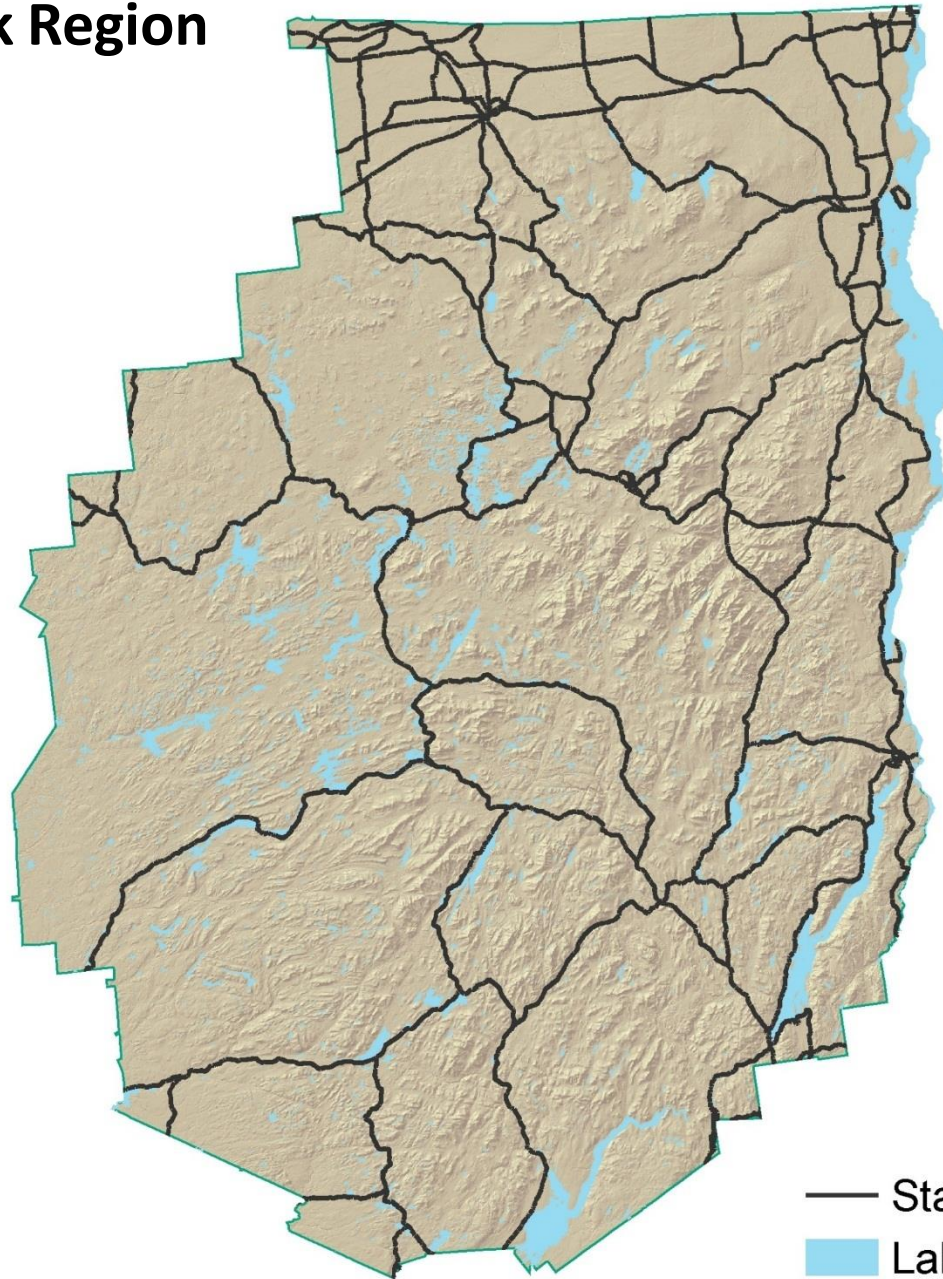
State Roads Within the Adirondack Region

- State Road Cooridor
- Lake/Pond

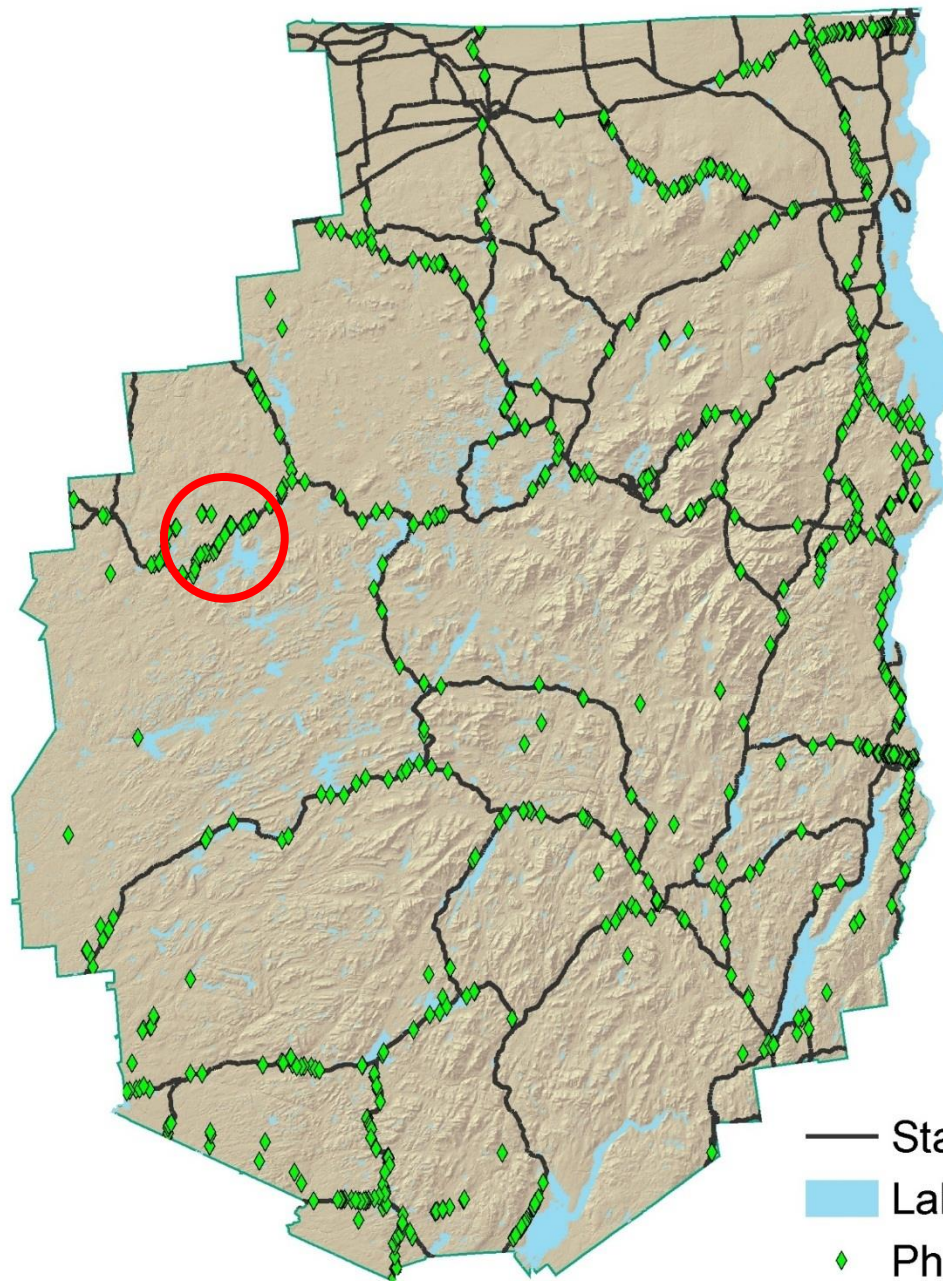
- State Road Cooridor
- Lake/Pond
- ◆ *Phragmites australis*

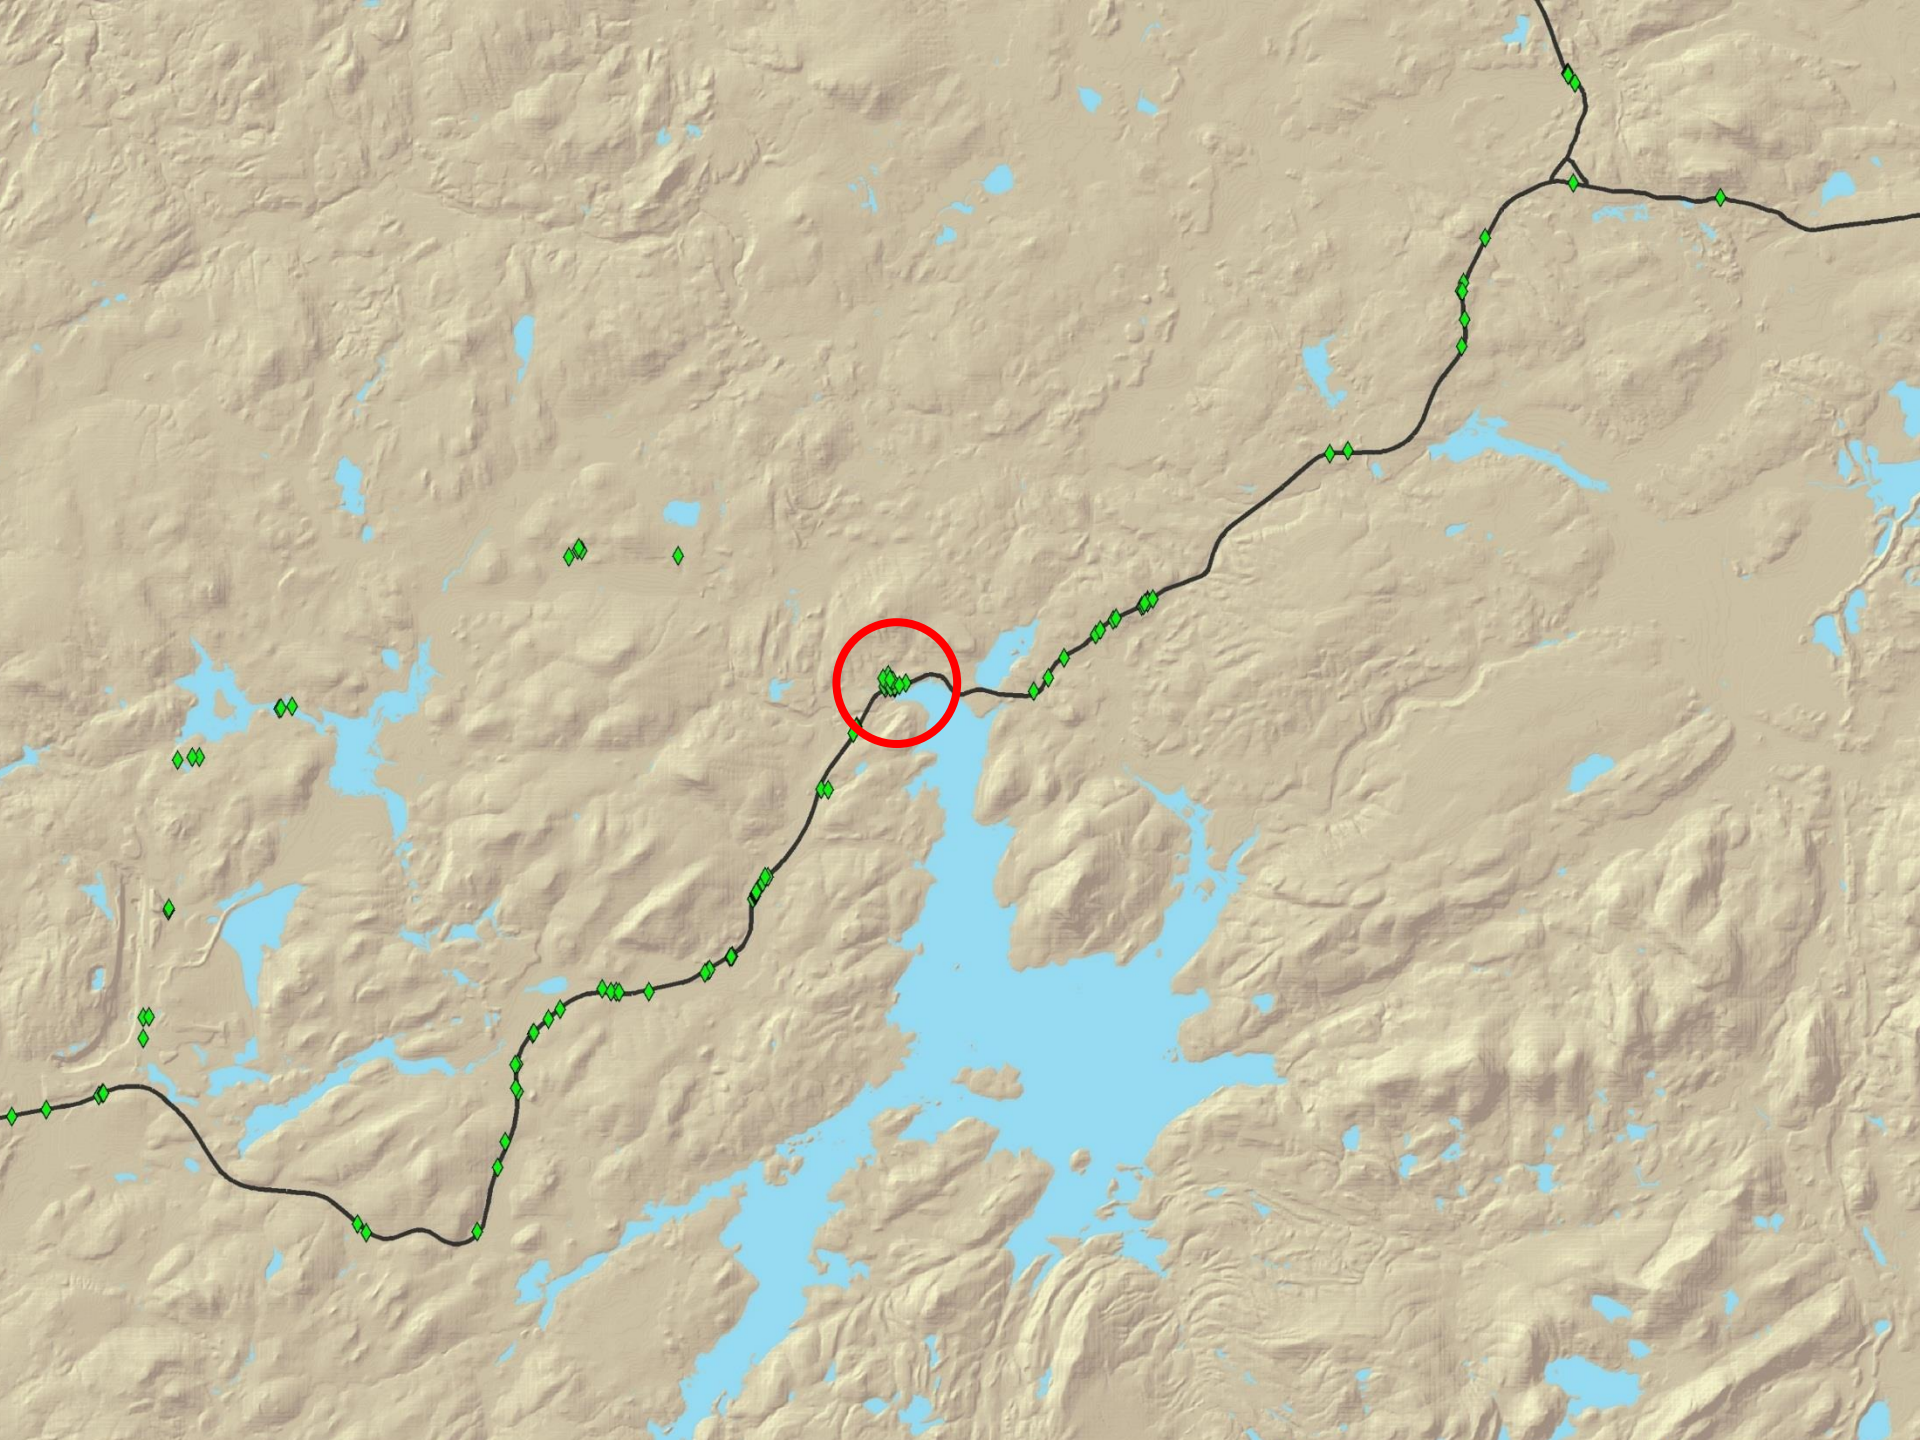
NYSDOT Residency - Cranberry Lake

◆ *Phragmites australis*

■ Infestation Extent

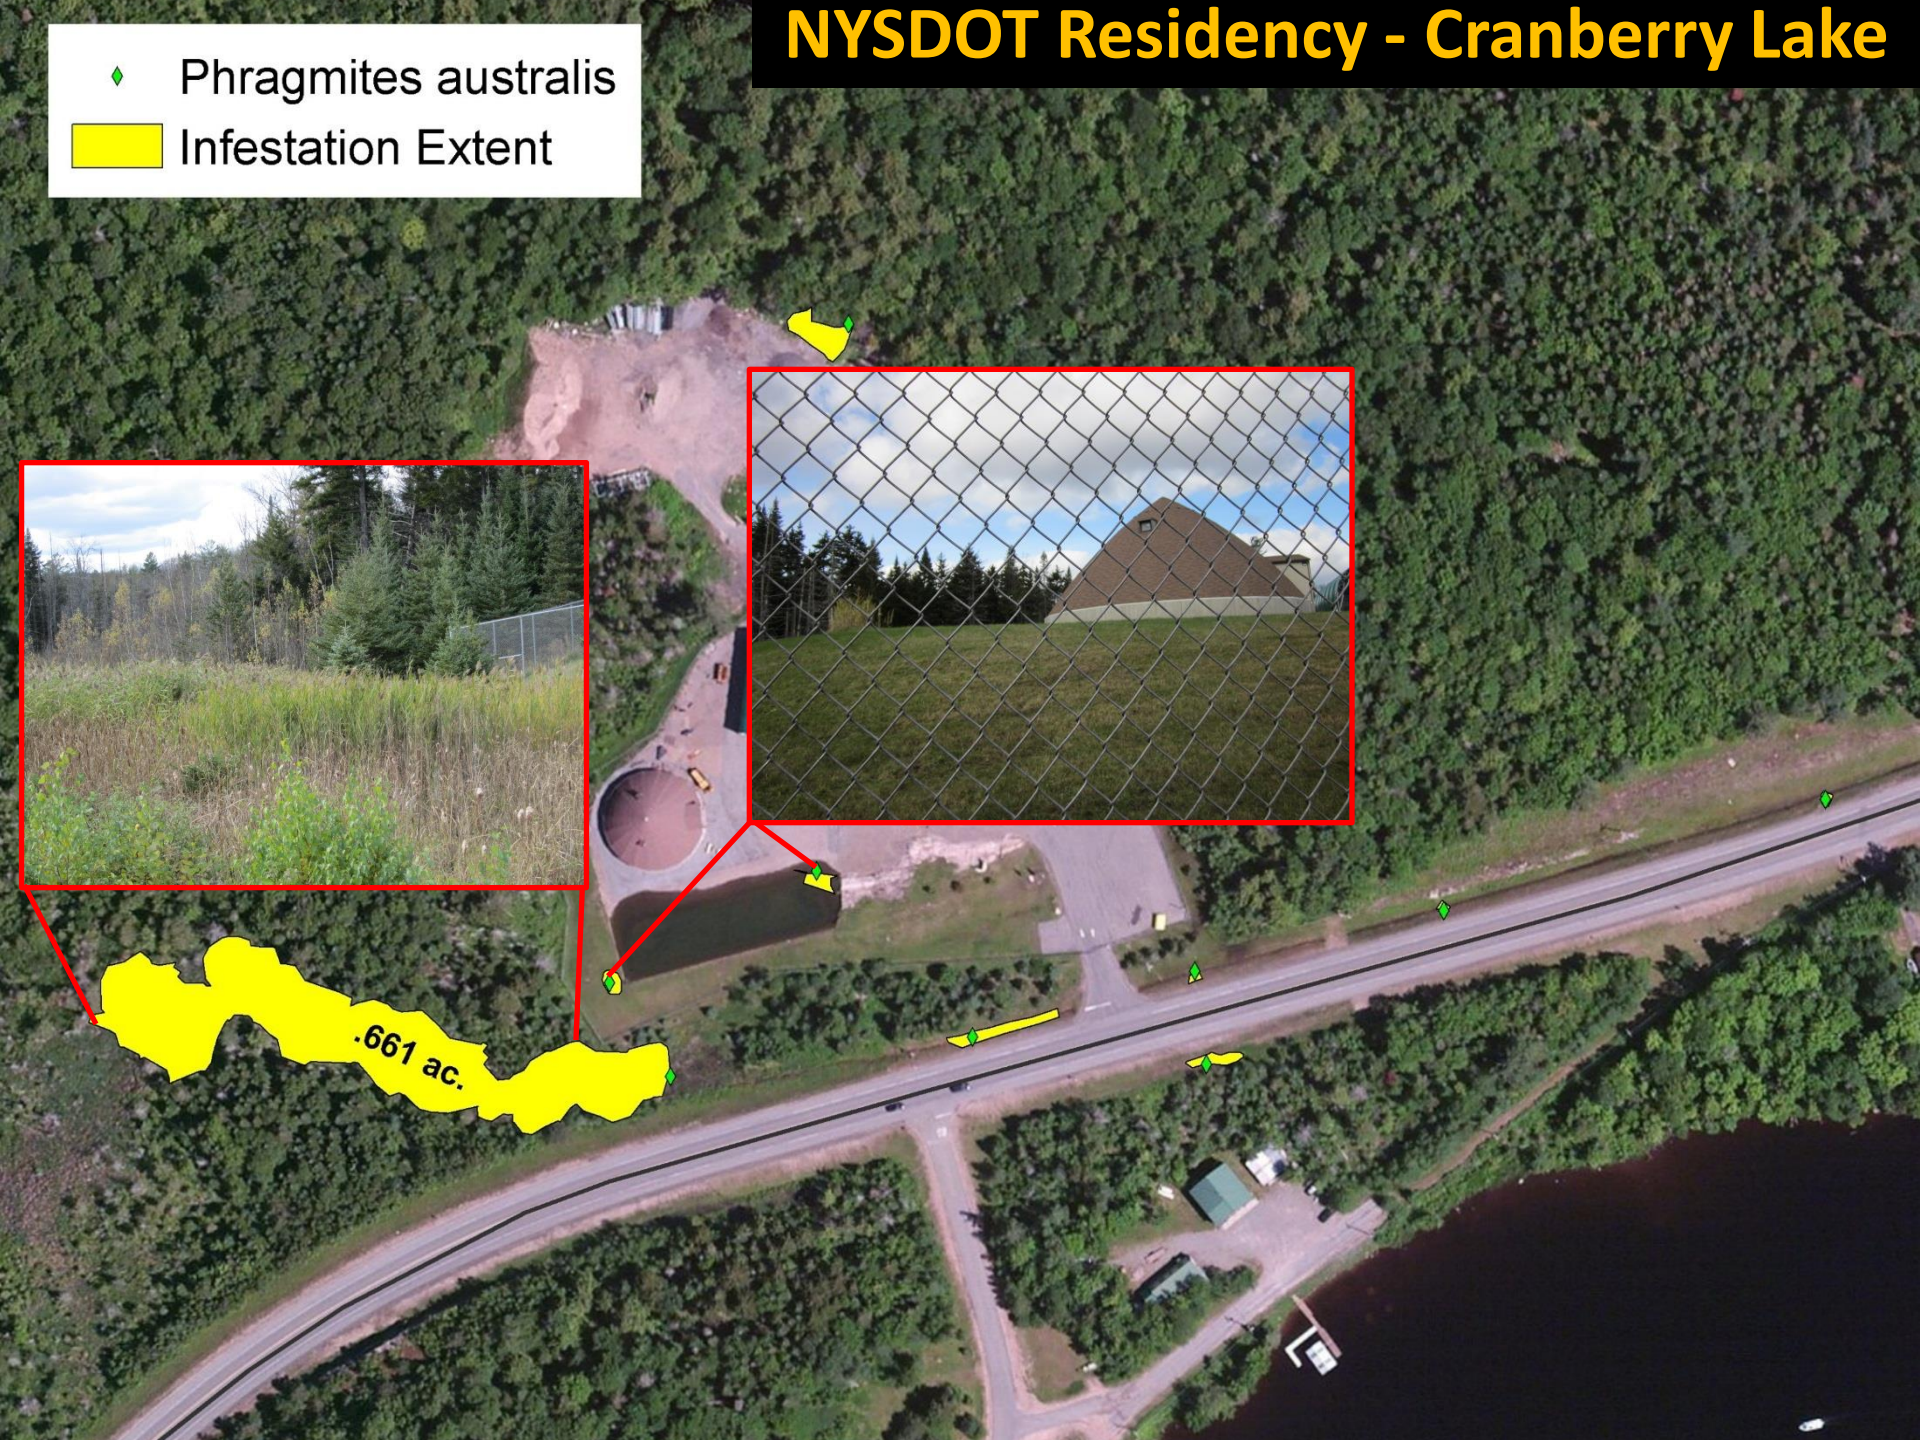
Phragmites australis Infestation

Infestation's Extent

Wetland

~37.5 ac.

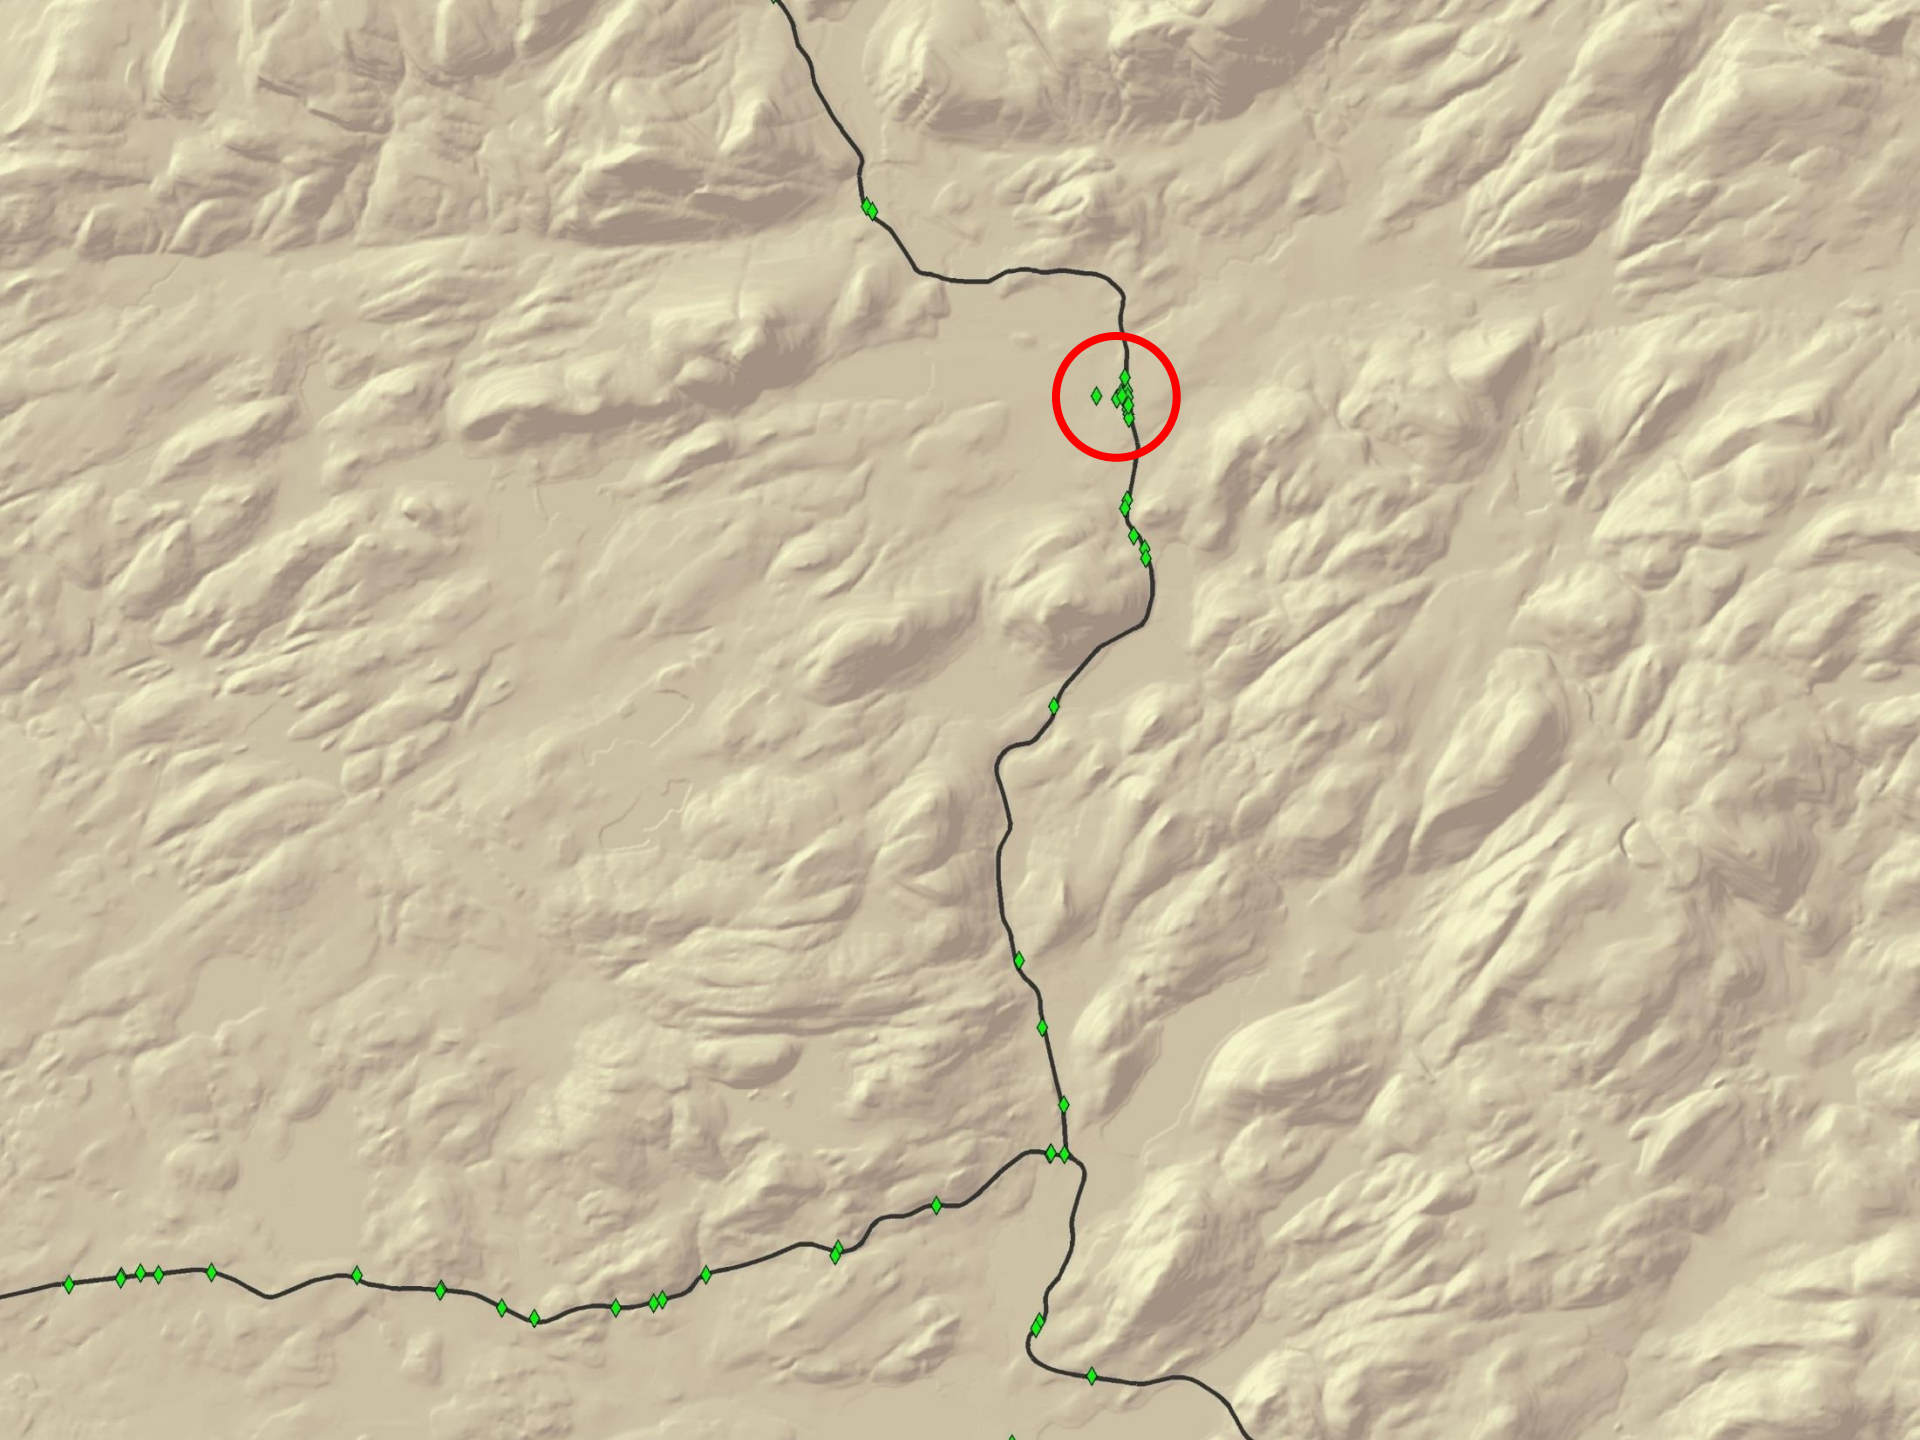
◆ *Phragmites australis*

■ Infestation Extent

1.066 ac.

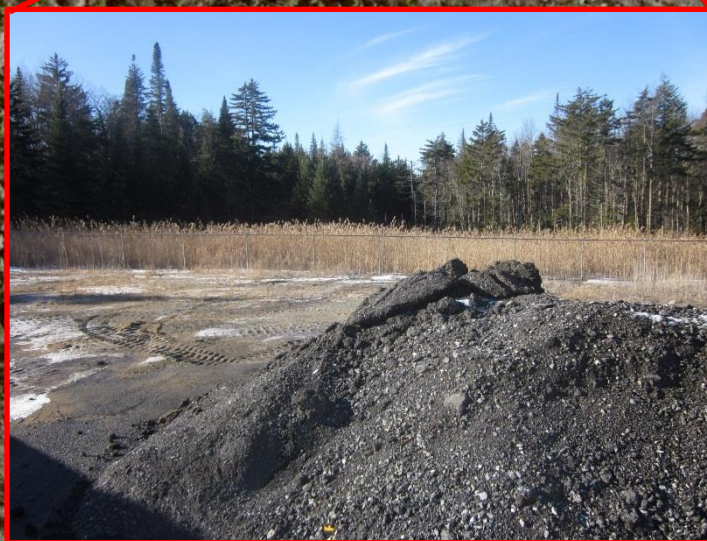
◆ *Phragmites australis*

■ Infestation Extent

■ Wetland

~479 ac.

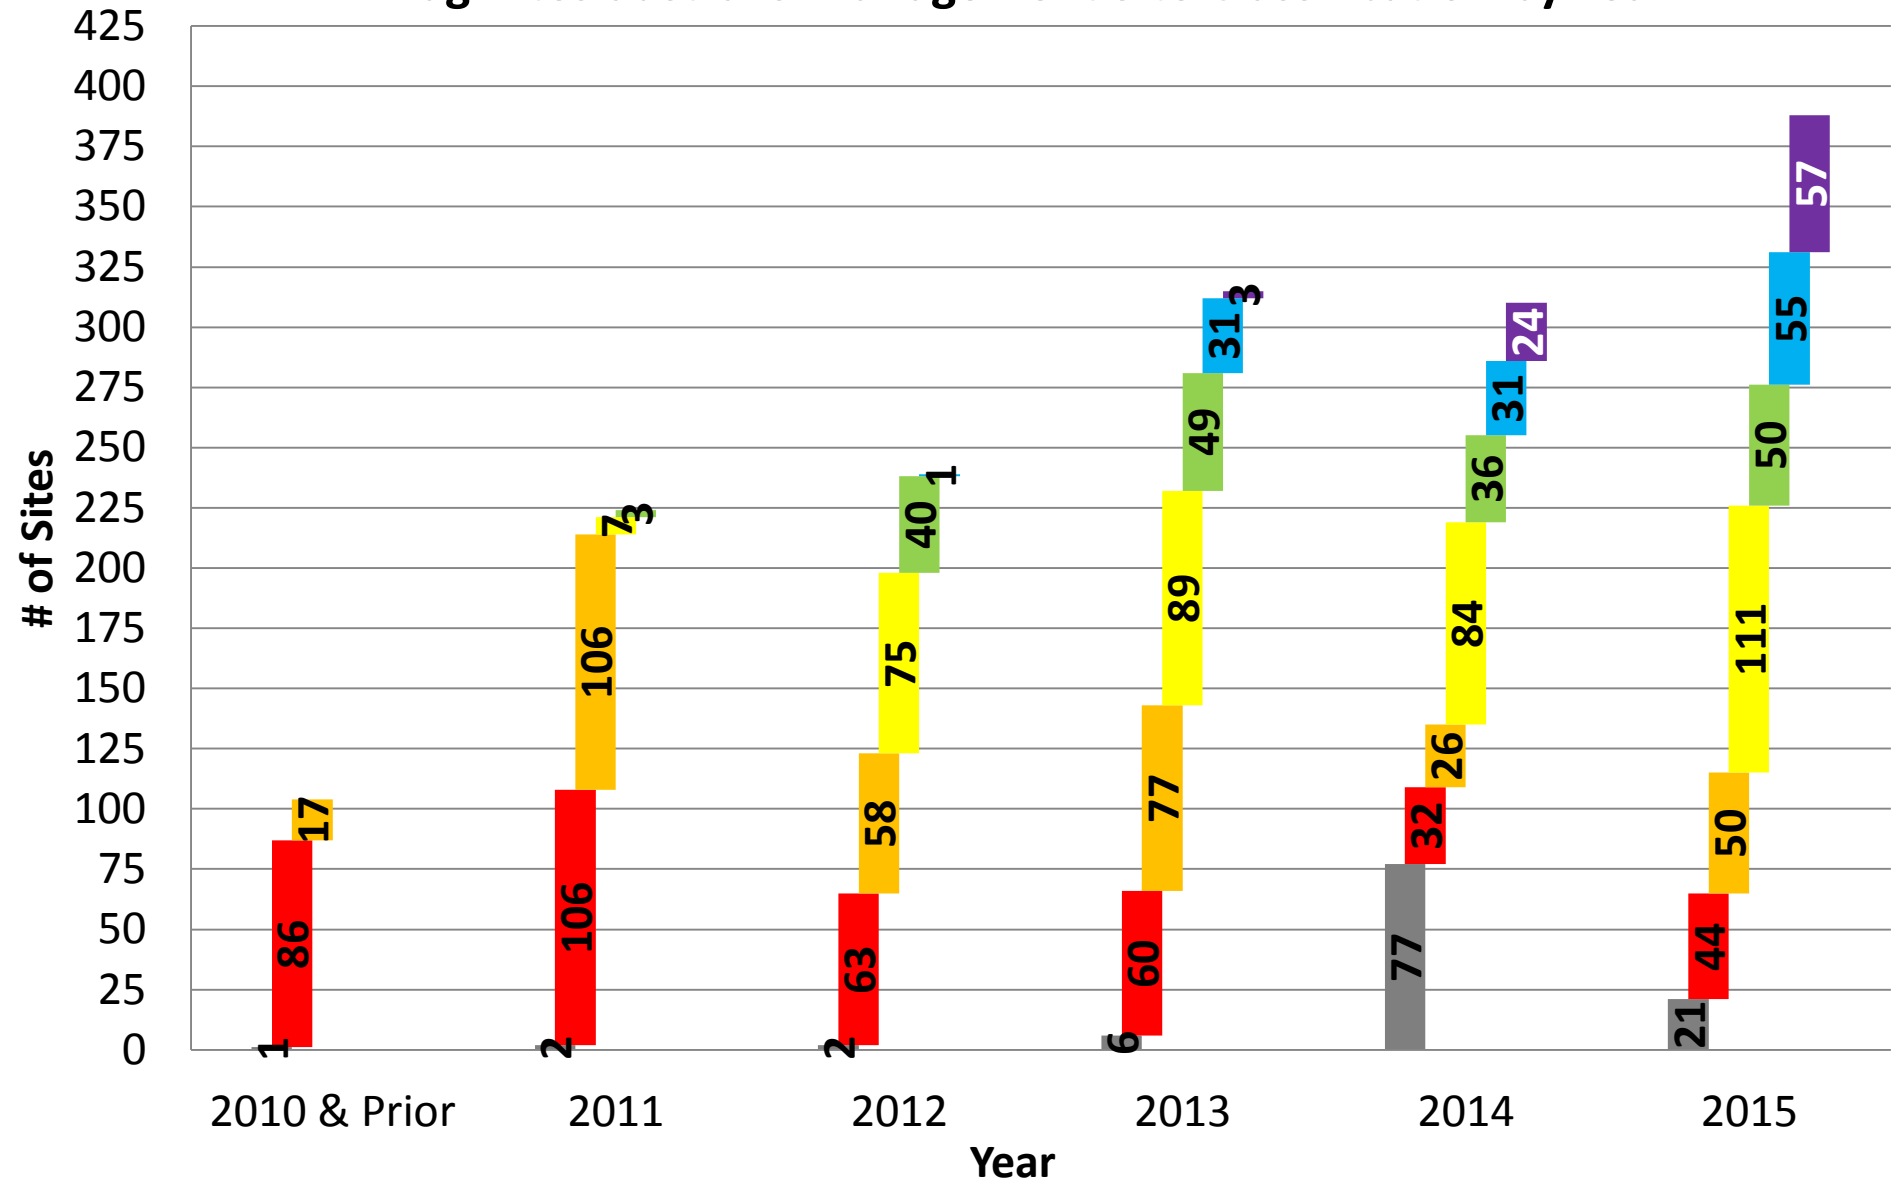
Phragmites australis Management Site Classification by Year

■ Unassessed, Untreated, or No Data

■ New Sites Documented

■ Initial Treatments Performed

■ Follow-up Treatments Performed

■ No Plants Observed Year 1

■ No Plants Observed Year 2

■ Eliminated
