Office of Strategic Planning and Projects
Connecticut Department of Transportation

CLIMATE CHANGE & EXTREME WEATHER PILOT PROJECT

LITCHFIELD HILLS

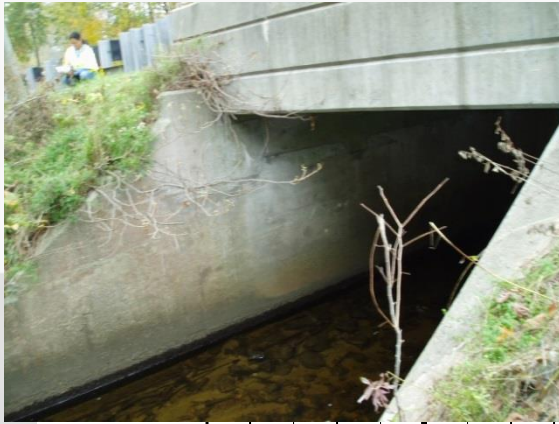
Structure: 06712
Location: Watertown

CRITICALITY MATRIX

Year Built: 1966
Criticality Ranking: 4

Very Low to Low			Moderate				Critical to Very Critical		
		1	2	3	4	5	6	7	8	9	10
Hydraulic	High adaptive capacity				Moderate adaptive capacity				Low adaptive capacity		
	No history of closure				History of periodic closures				Significant history of closure		
	Satisfies WSE criteria				Adjacent to scour critical structures				Scour critical		
Spatial	Outside FEMA flood zones				Within 500 year FEMA flood zone				Within 100 year FEMA flood zone		
	Low concentration of impervious surfaces				Moderate concentration of impermeable surfaces				High concentration of impermeable surfaces		
Social	Low ADT & V/C				Moderate ADT & V/C				High ADT & V/C		
	0-4 accidents				5 or more accidents				Emergency route		
	Non-NHS, non-emergency route				NHS route				Emergency services cluster

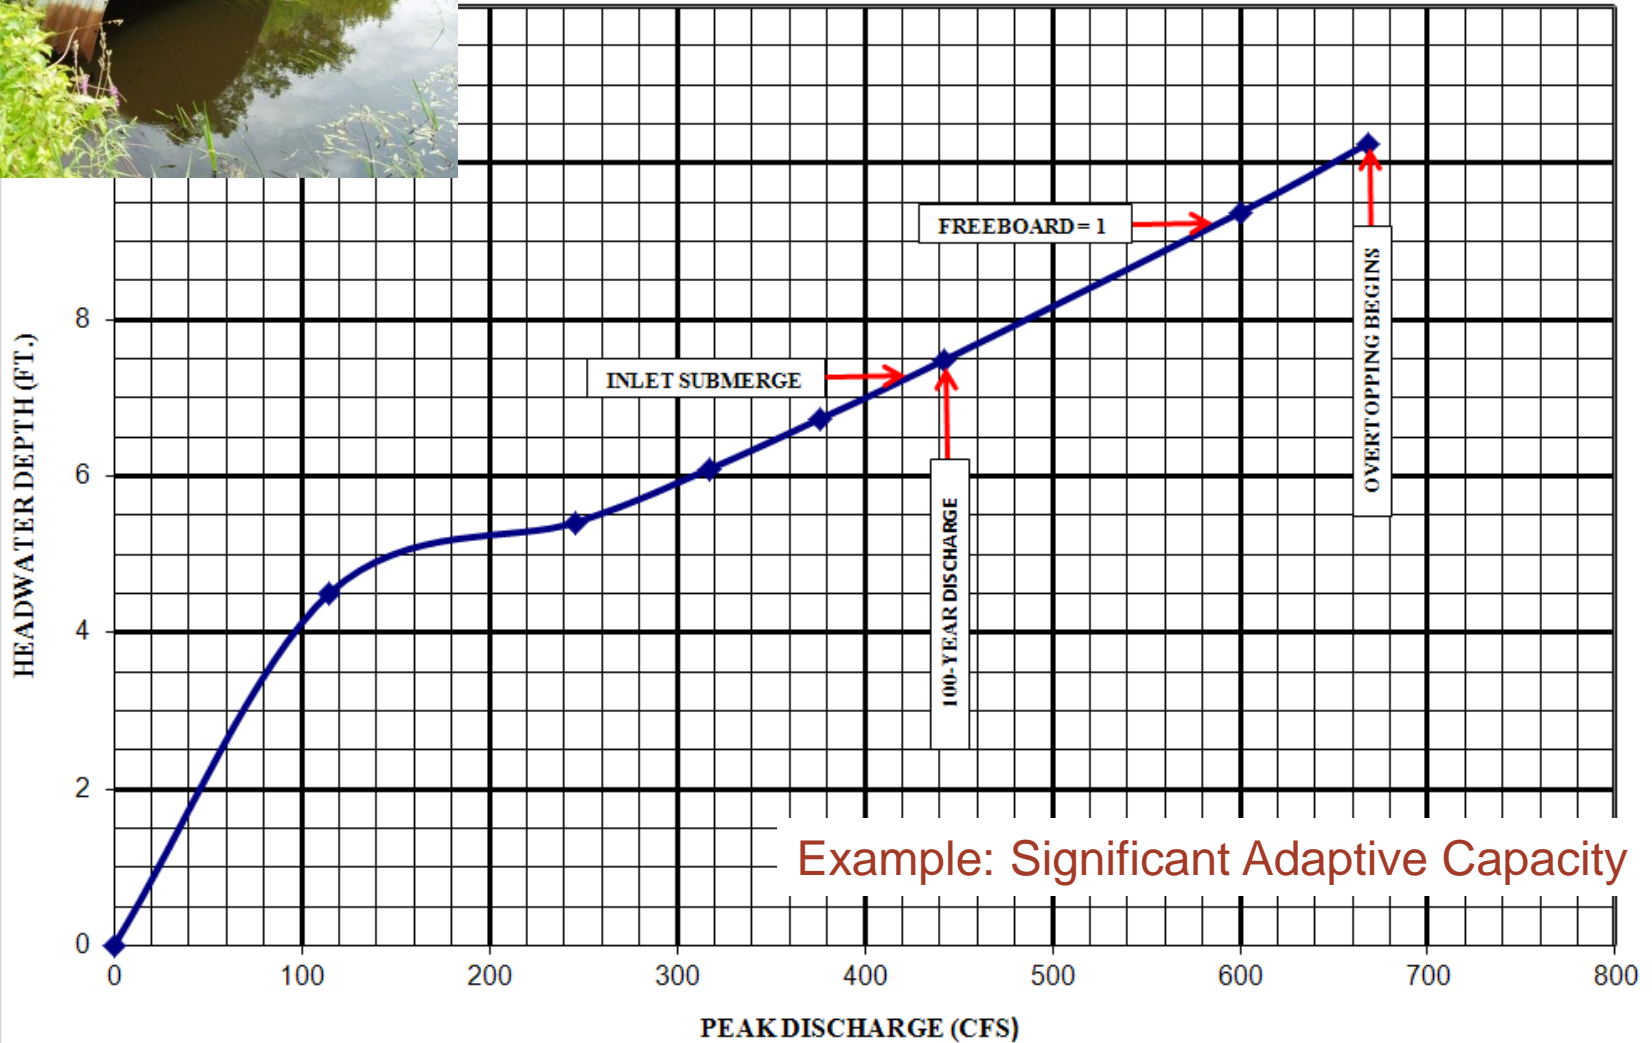
STRUCTURE NO. 05417
HEADWATER DEPTH VS. PEAK DISCHARGE

Morris- Route 109

- Hydraulic Evaluations
 - Performance (Rating) curves for structures:
 - Headwater depth vs. peak discharge
 - Velocity vs. peak discharge
- Criticality/Vulnerability Assessments:
 - Criticality Matrix
 - Criticality ranking for structures

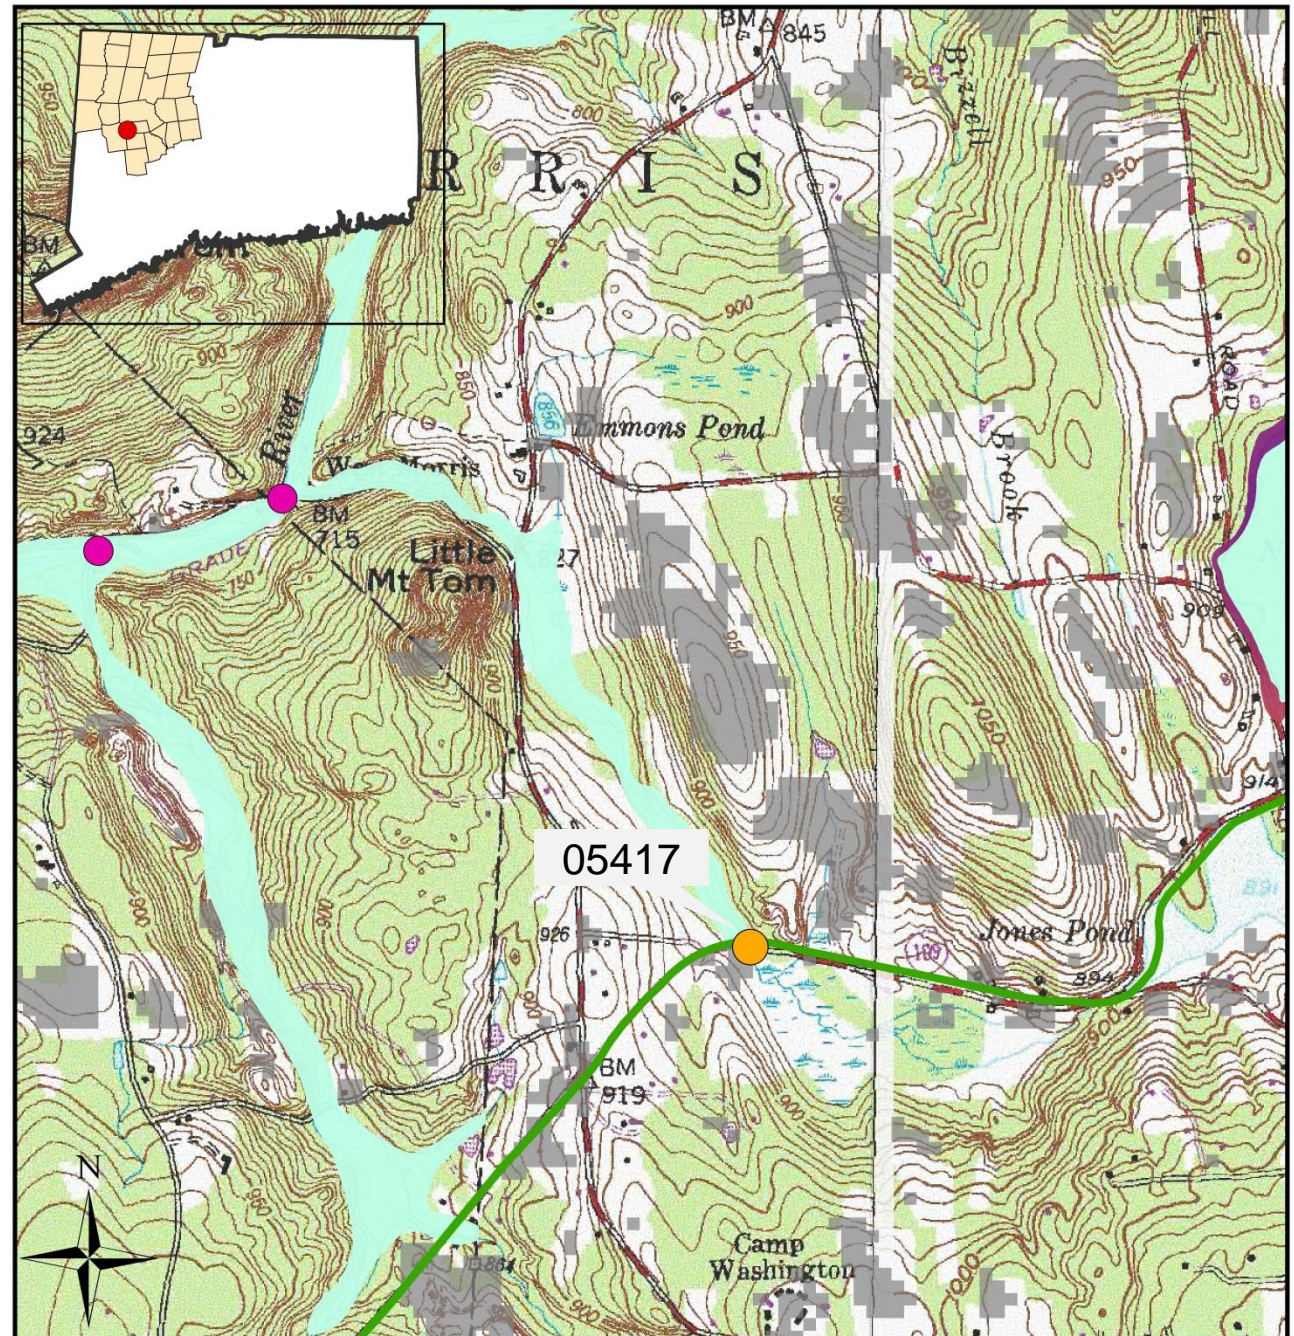
Criticality Score: 8

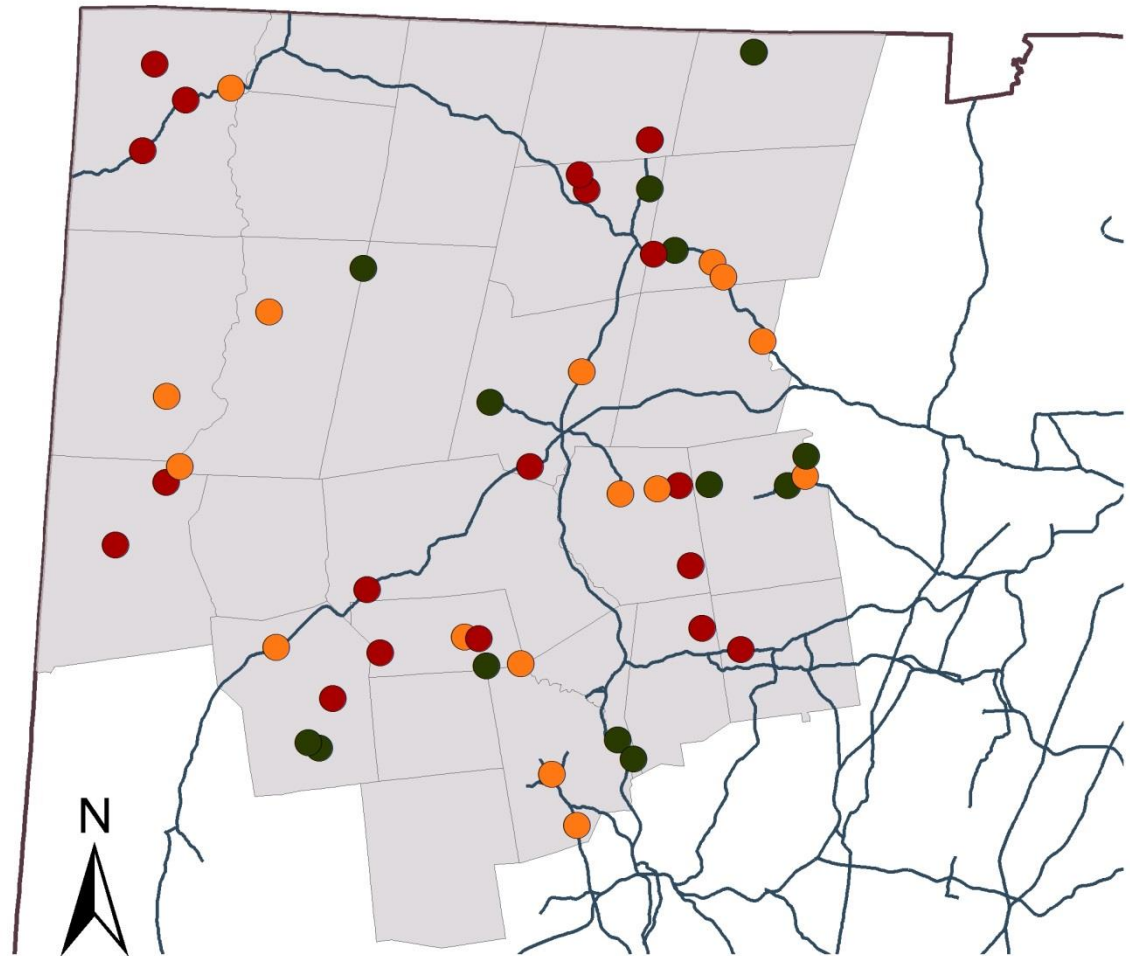
Litchfield Hills Study Structures Criticality Rankings

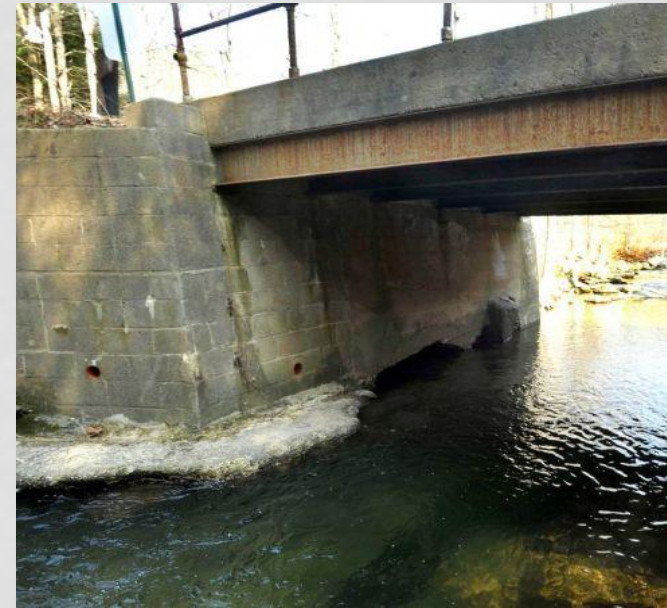
Example of bridge scour, New Milford

- Velocity-erosion-scour impact vulnerability and adaptive capacity
- Many structures near end of their service life may be more vulnerable
- Hydraulic design methods of older structures are unknown
- Precipitation Estimates
 - Precip.net vs. TP-40
 - NOAA Atlas 14 will be used when released
 - Precip.net estimates higher for less frequent storm events (500, 100, 50 year)
