“Boots on the Ground” Are Already Going Green:

Stream Restoration Best Management Practices from Maintenance Programs

Northeastern Transportation & Wildlife Conference
Wednesday, September 14, 2016

James W. Buck, CPESC
Maintenance Environmental Coordinator
Region 9 - Operations

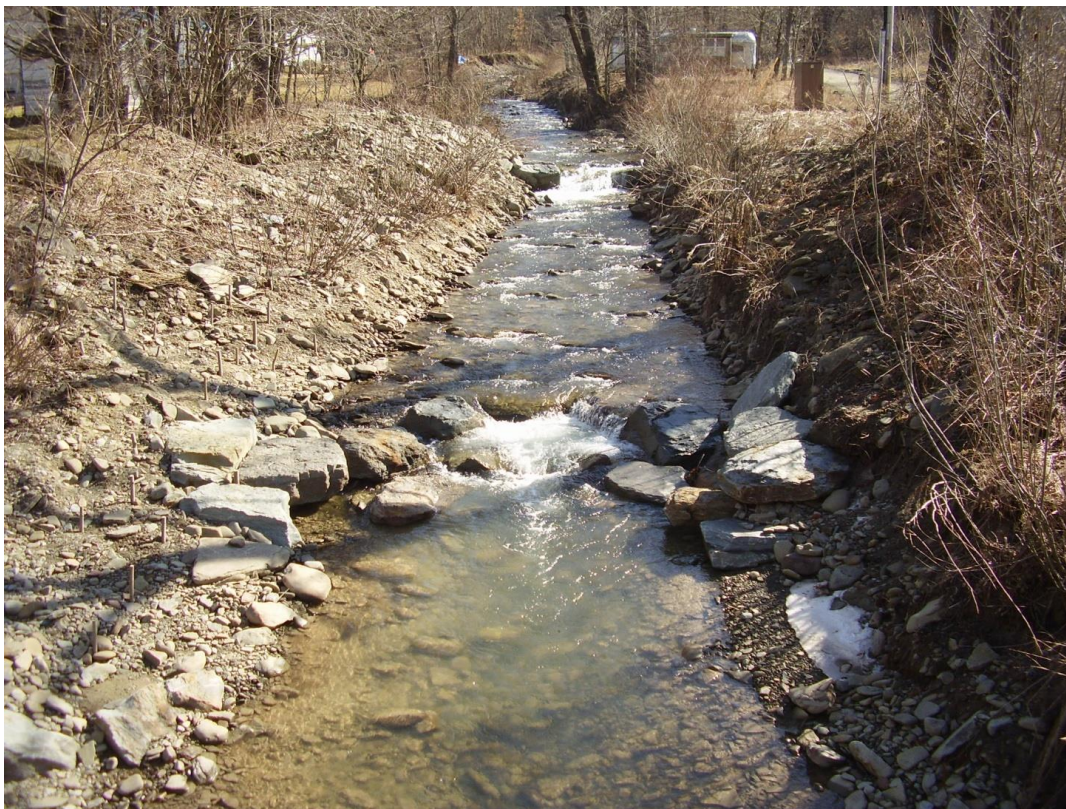
Kerryville Brook

➤ 2 Cross vanes were installed upstream of the NYS Route 268 culvert structure.

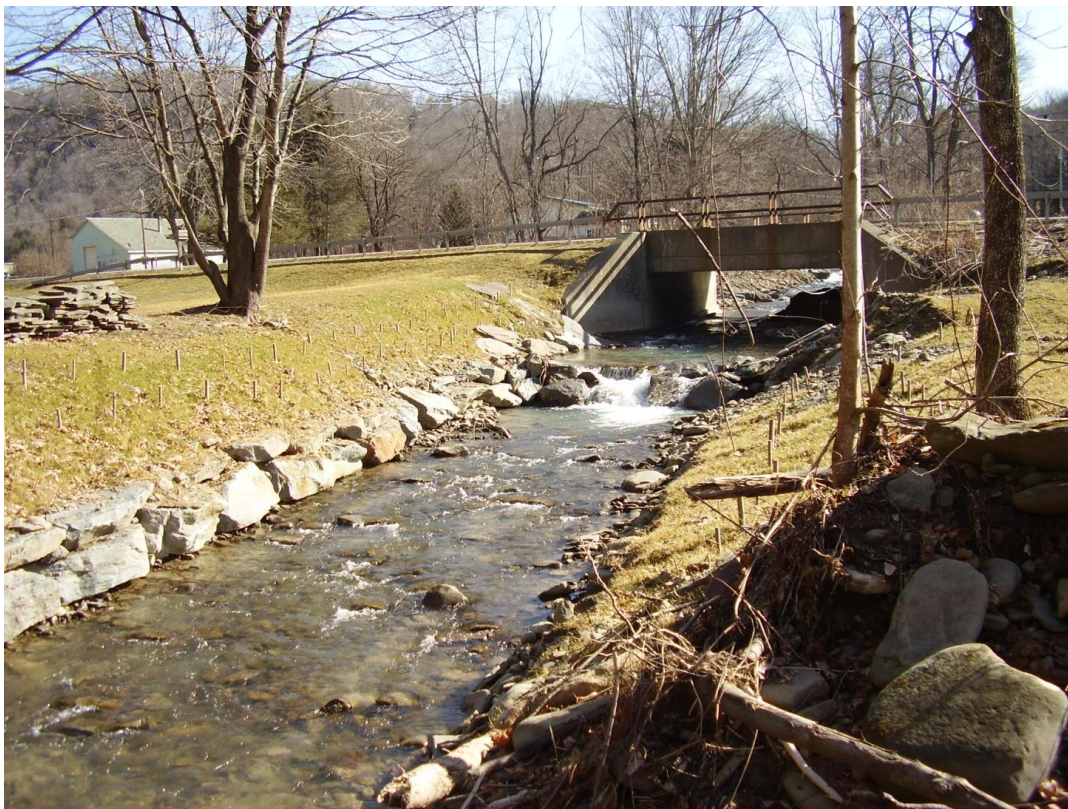
Kerryville Brook

- Accumulated sediments were removed from under culvert structure using a walk-behind tracked loader.
- 1 Cross vane was installed downstream of NYS Route 268 culvert structure.
- Heavy stone protection was added at the toe of slope.

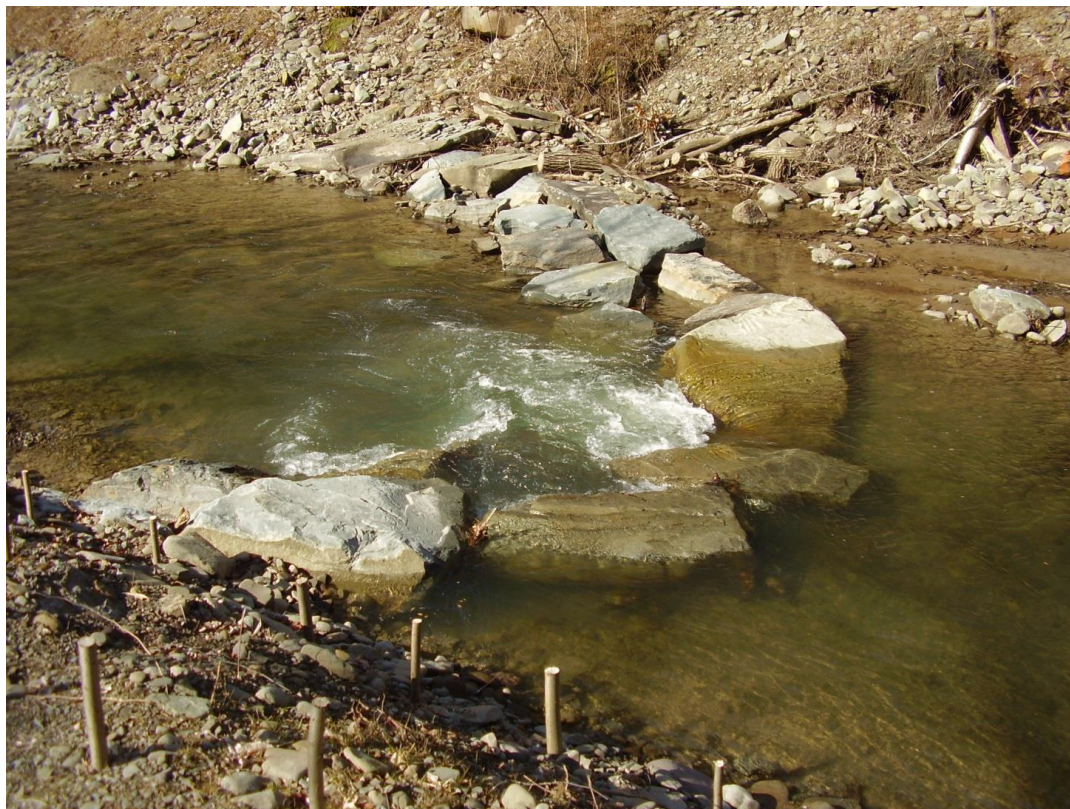
- Cross vanes were installed in Cadosia Creek between the confluence with Kerryville Brook and the NYS Route 268 over Cadosia Creek bridge structure.

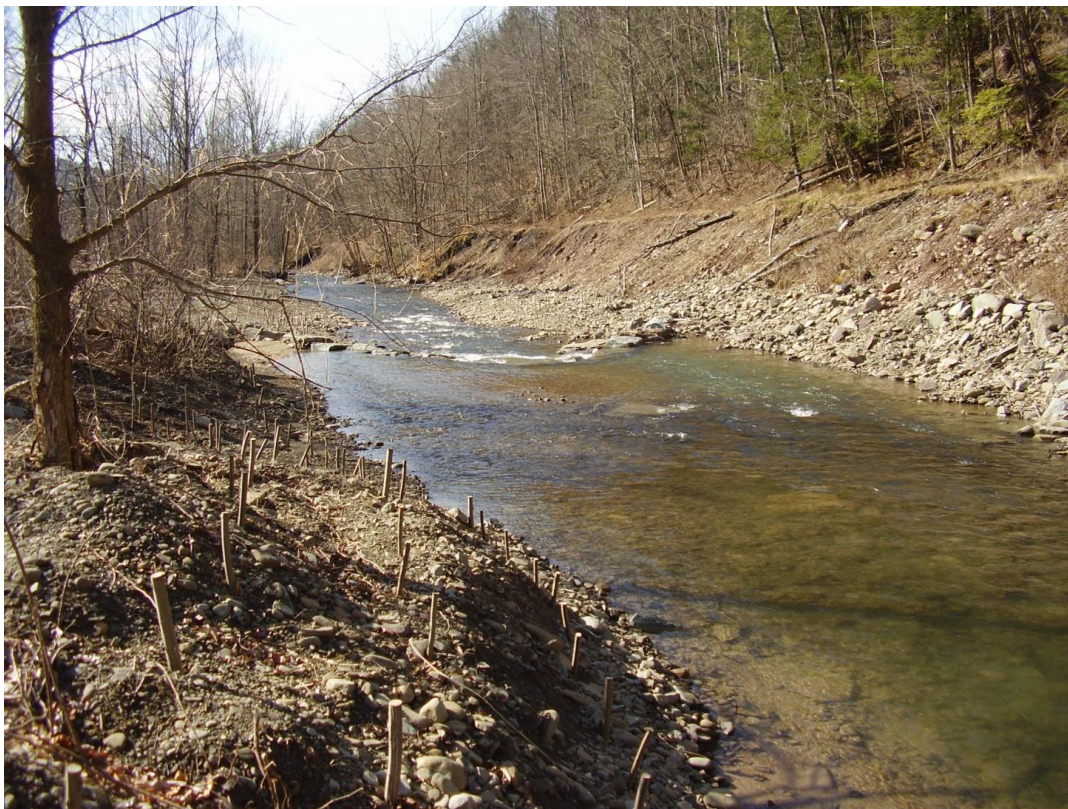
Cadosia Creek

- Removed an average of 2.0 feet of accumulated sediments from active channel to establish a single channel.
- Established a flood plain bench below abandoned O & W Railroad Line.
- Used root wads, where available, as bank protection.

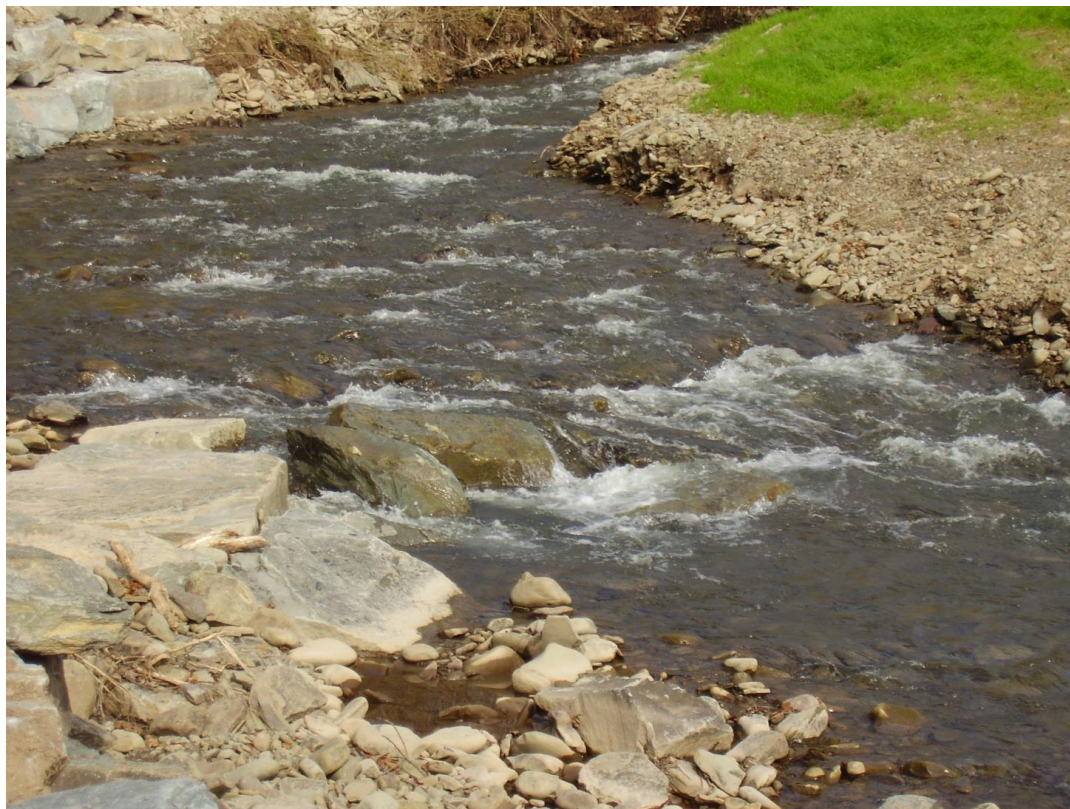
- Installed 2 straight vanes within channel immediately upstream of NYS Route 268 over Cadosia Creek bridge structure.

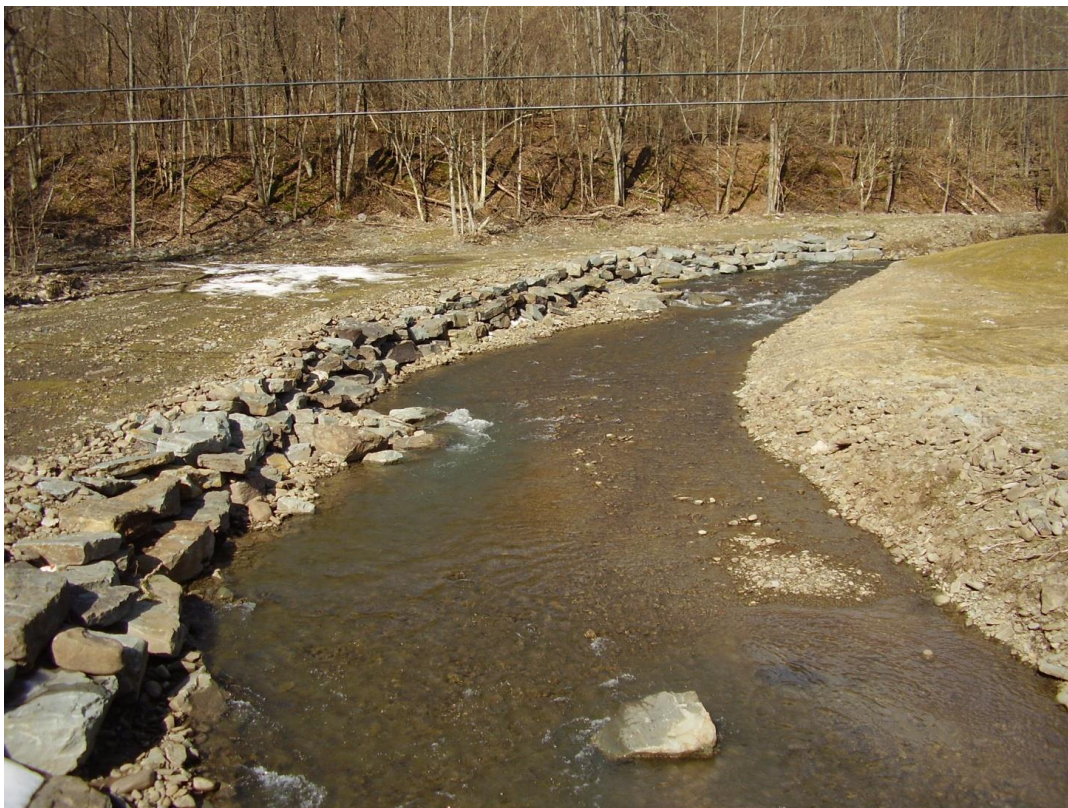
- Installed 2 straight vanes within channel immediately upstream of NYS Route 268 over Cadosia Creek bridge structure.
- Installed stacked heavy stone as bank protection upstream of inlet to NYS Route 268 over Cadosia Creek bridge structure.

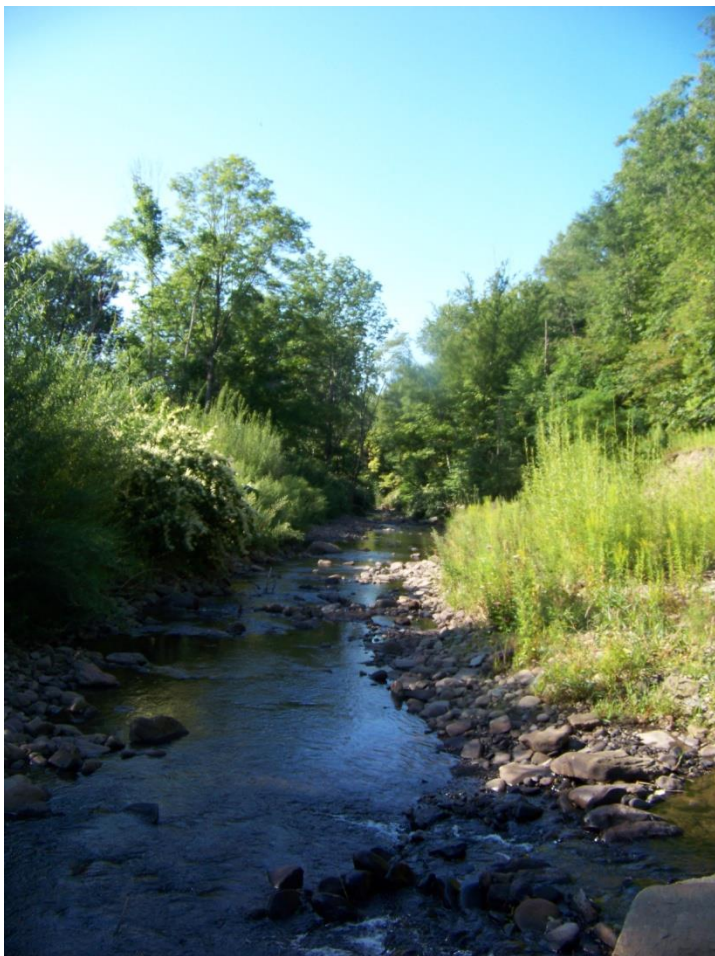
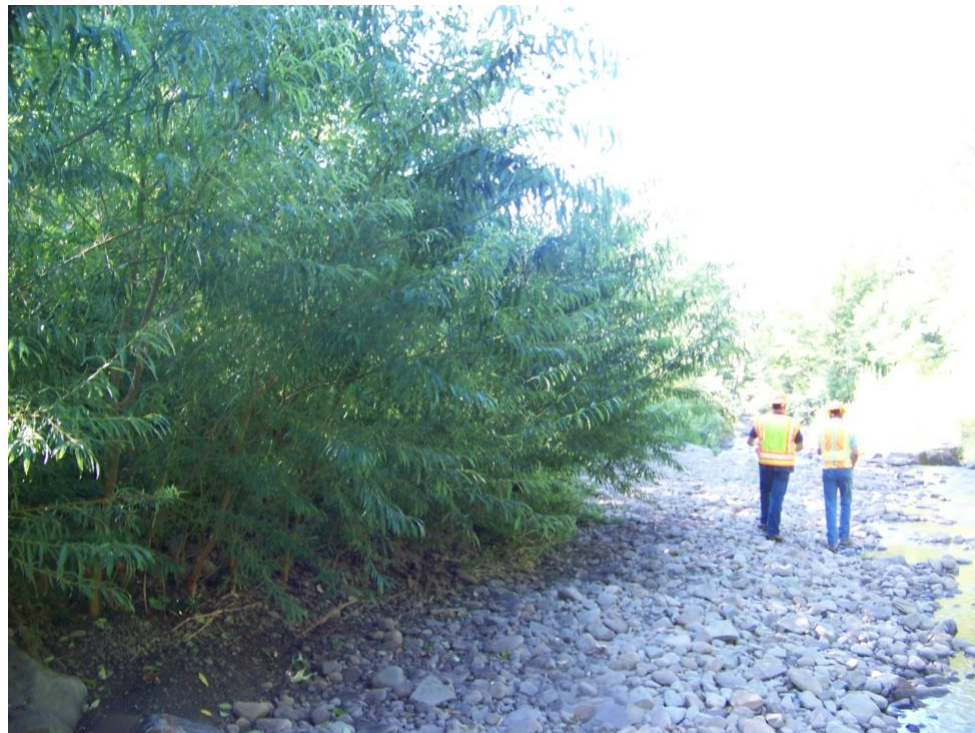
Vegetation – 2 years later

Over 1500 Hybrid Willow (*Salix* spp.) were installed in the fall of 2011.

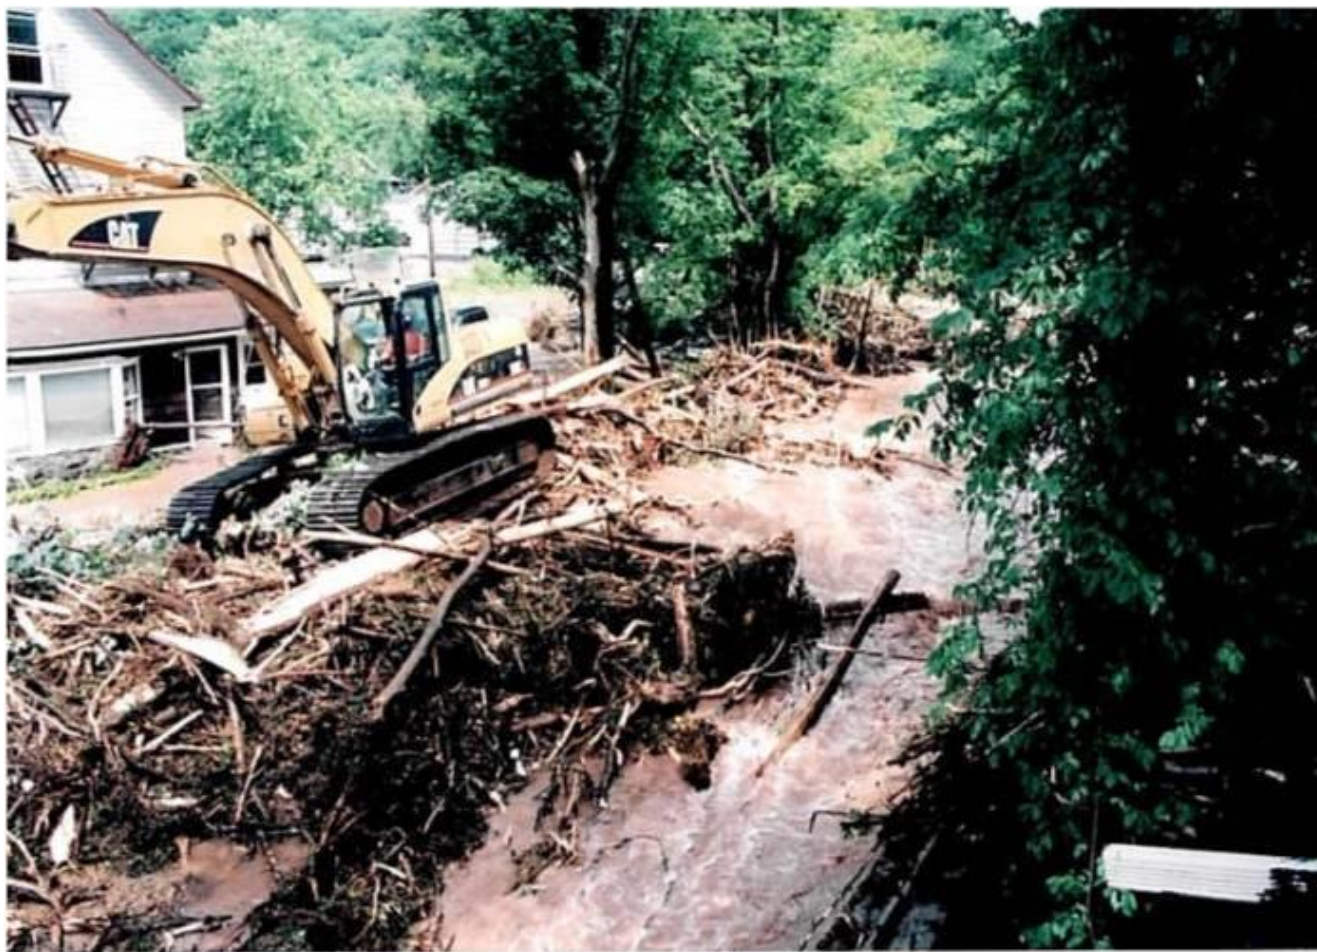
Panther Rock Creek: 2006 Flood

- ➡ “Floods of Record” occurred on June 26, 2006 and June 28, 2006.
 - ❑ Caused many trees to fall into the stream.
 - ❑ Widespread bank erosion.
- ➡ In response to these floods, local officials hired contractors to “*Clean the streams*”.
 - ❑ Resulted in widespread destabilization of the banks.
 - Increased sediment loading and aggradation of the stream channel near the bridge.

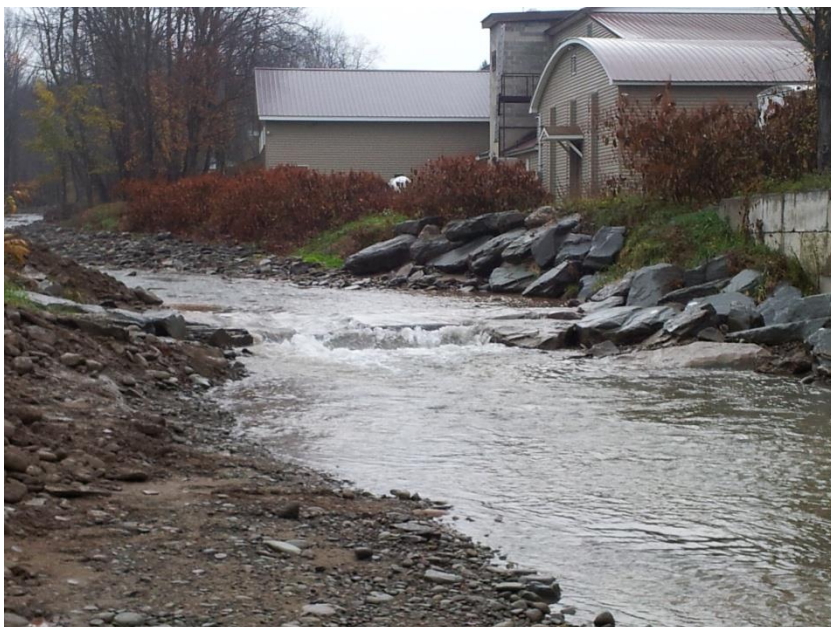
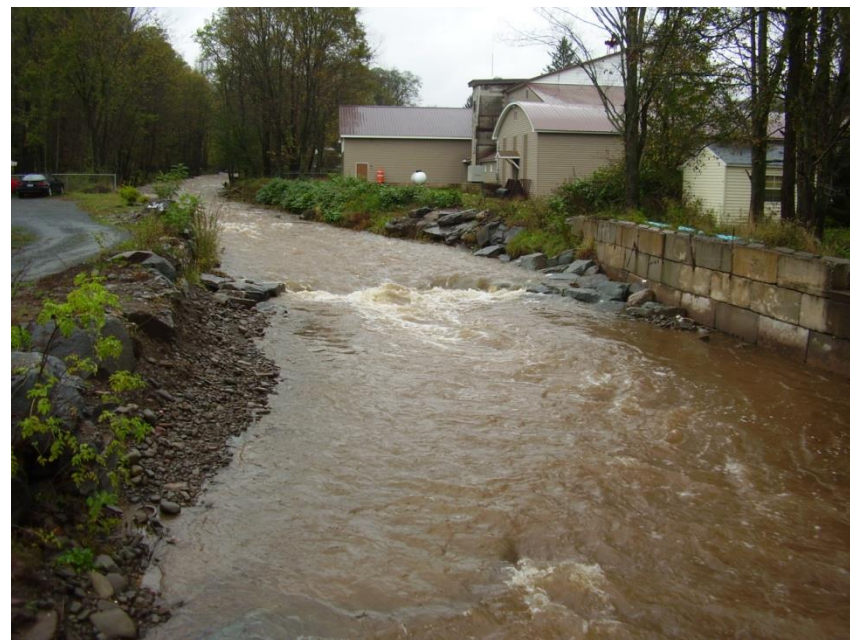
Panther Rock Creek – 2010

October 2010 – 1 month post construction

- ➔ Cross vanes facilitated the stream's ability to carry sediments through the structure for approximately 3 years without any maintenance required.
- ➔ This watershed had microburst (15 inches rainfall) on July 4, 2014.
 - ❑ Another “500 year flood” resulted.
 - ❑ Sediments needed to be removed from cross-vanes.
- ➔ Next step: A bridge replacement project is scheduled for 2017 to replace bridge with a larger structure to accommodate debris/sediment transport.
 - ❑ Involves the purchasing of private property and building removal.
