Louis Berger

10 Years of Post-Construction Monitoring of Constructed Vernal Pools for the Stewart Airport Interconnector Roadway

PROJECT OVERVIEW

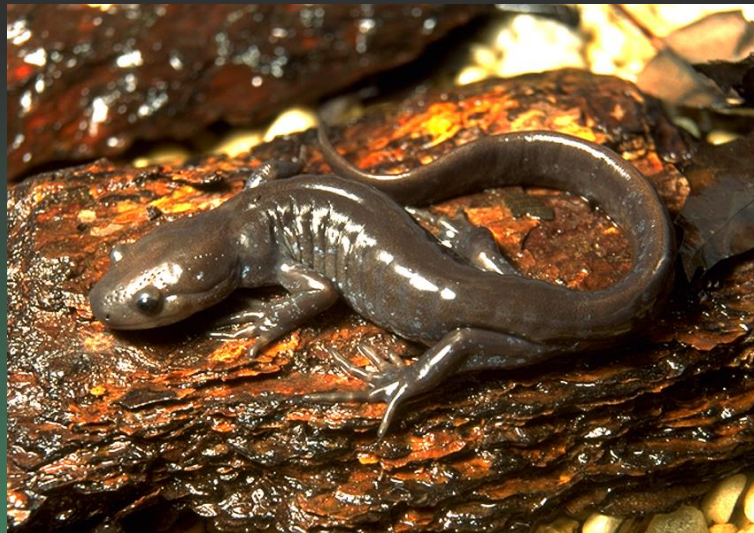
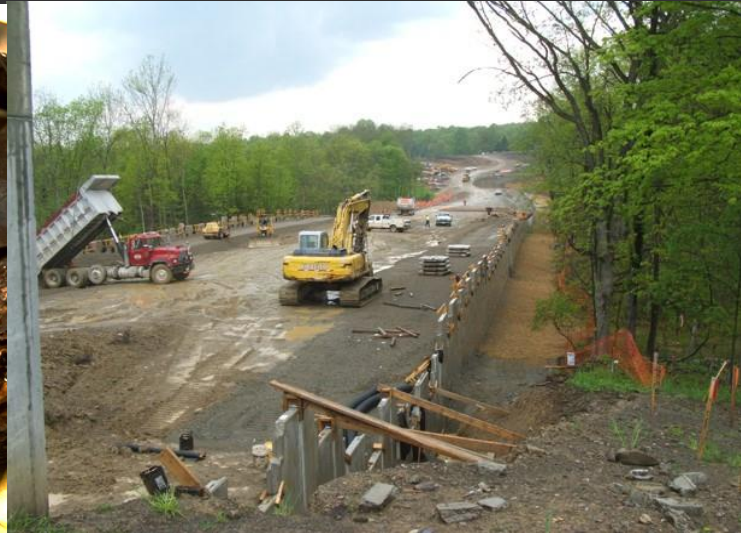
12 vernal pools constructed in 2006– B,C,D,F,H,T,U,V,W,X,Y,Z totaling 1.37 acres

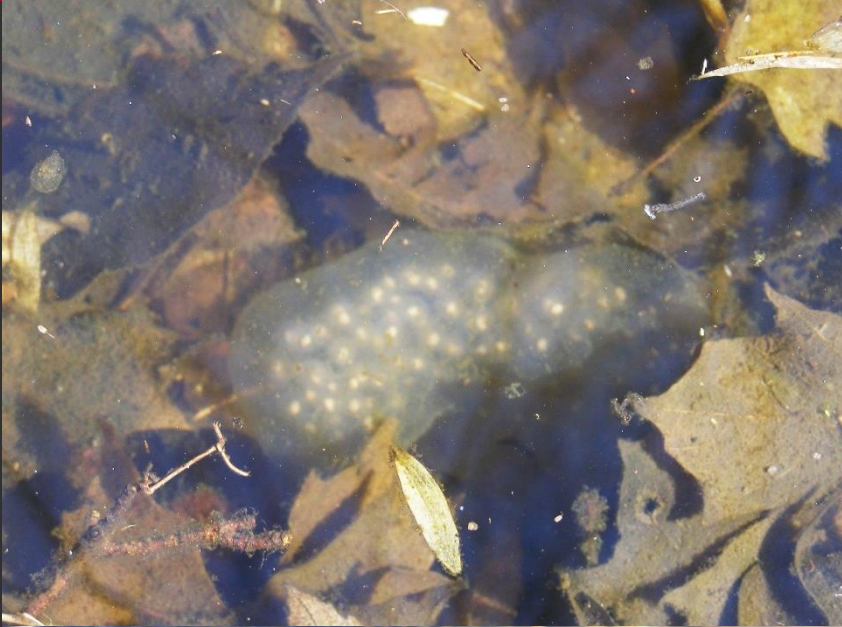
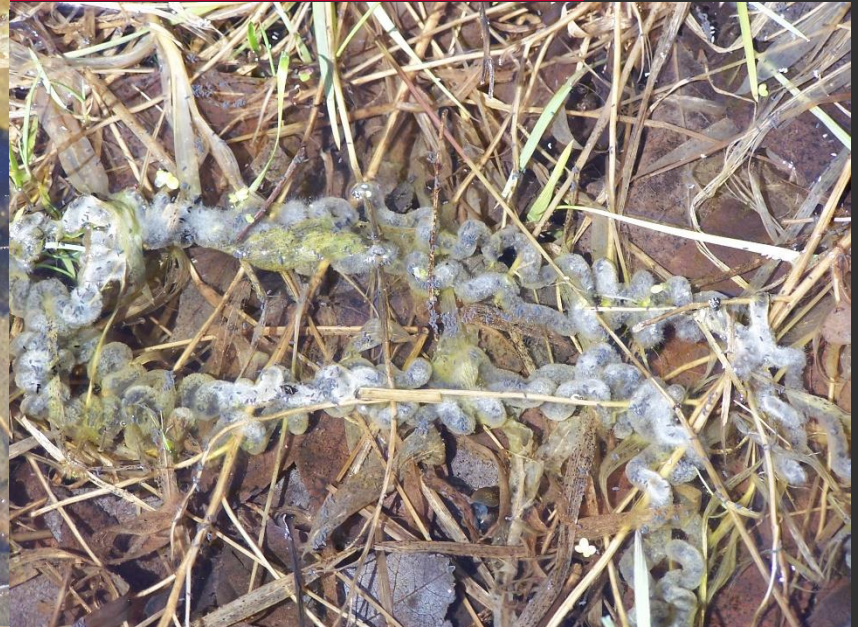
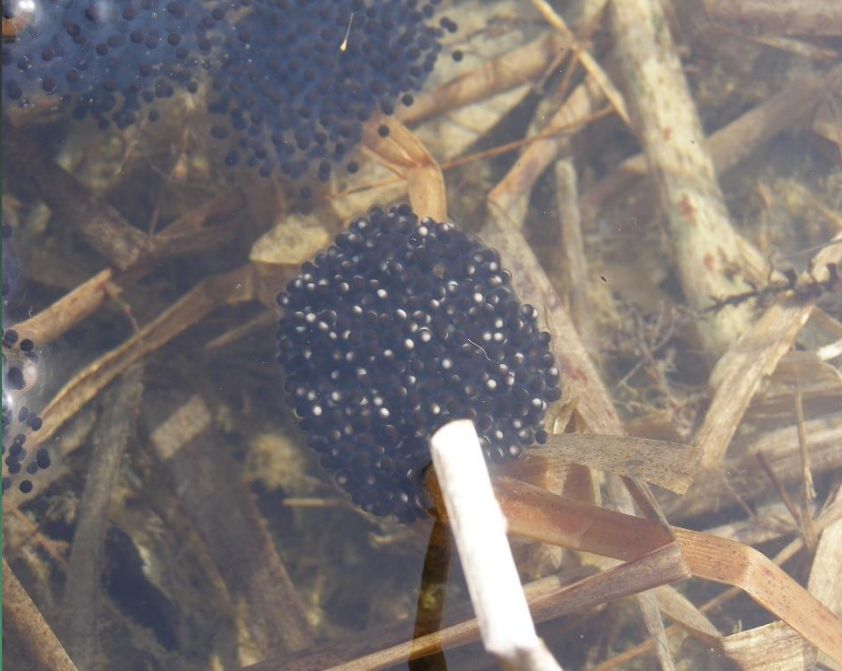
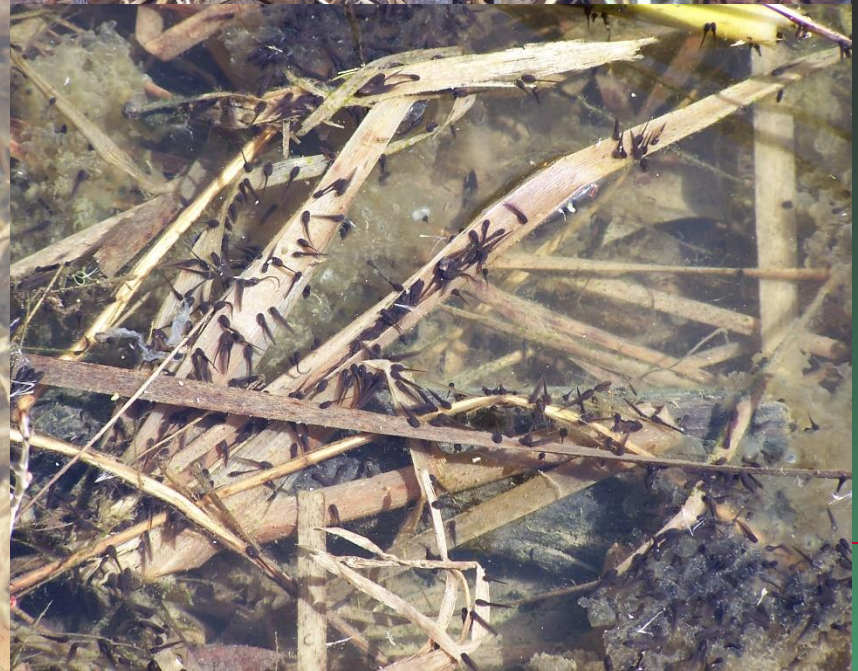
- 15 species of amphibians and reptiles observed
- 6 species confirmed breeders

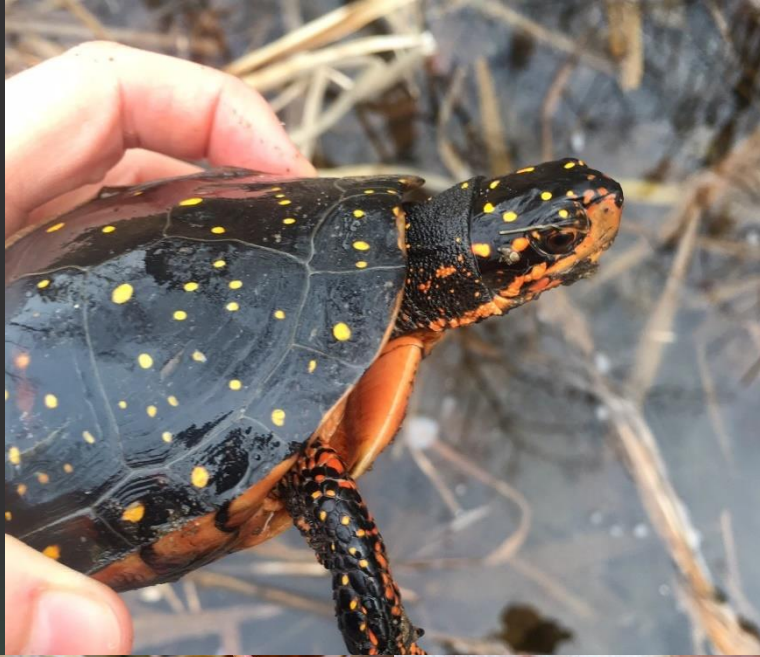
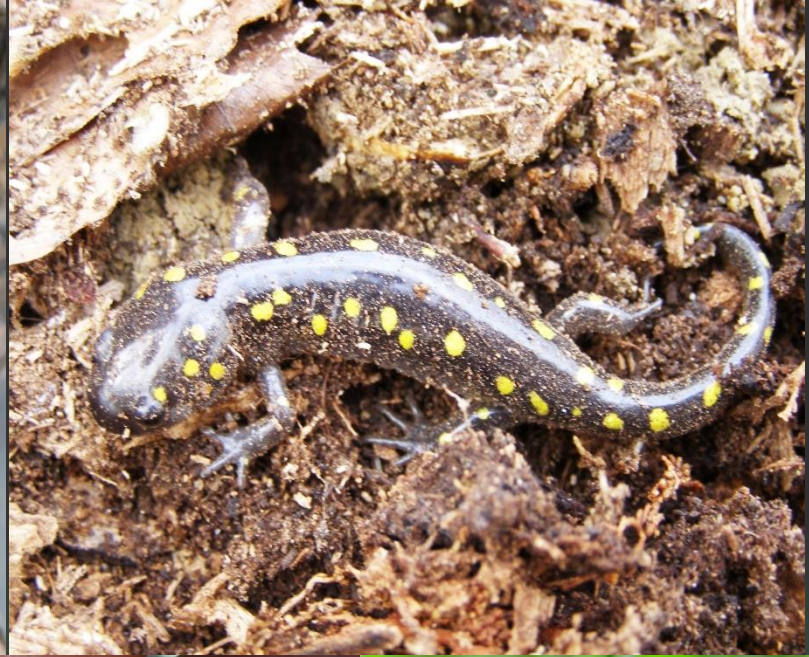
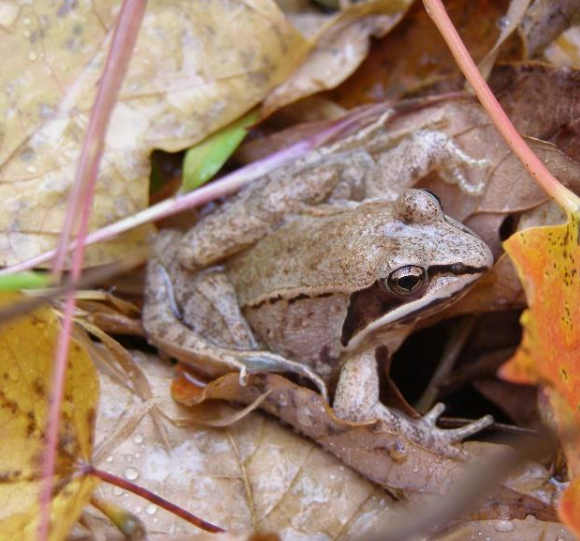
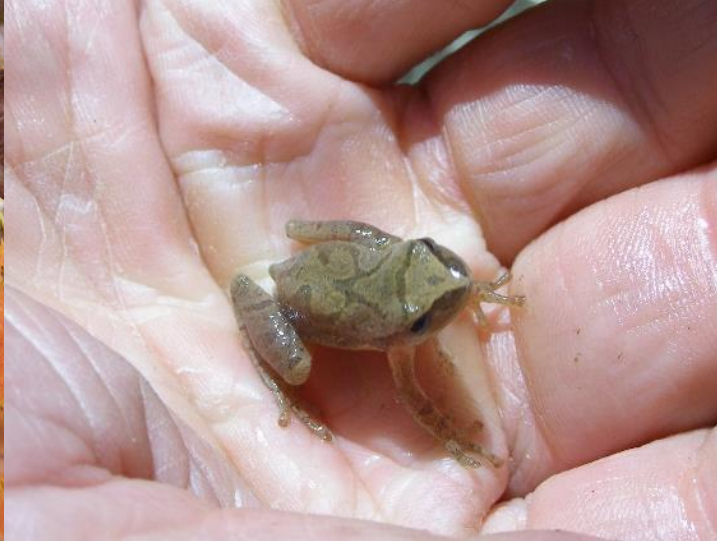
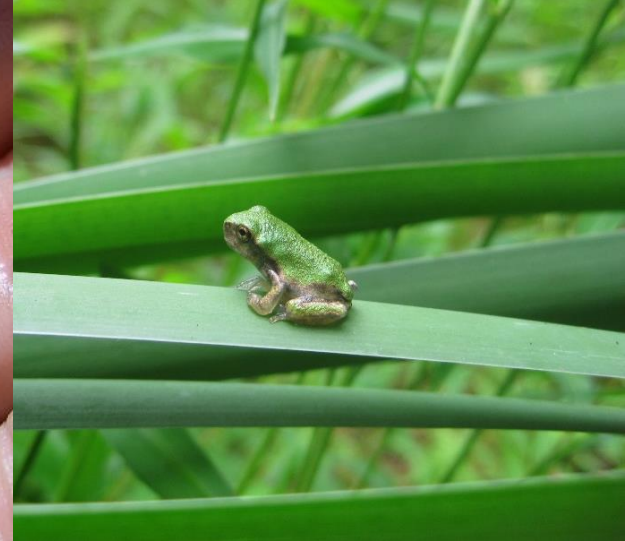
- Of 12 constructed pools, 6 have been observed to attract target species for 2+ consecutive years, over the 10-year monitoring period.
- This includes pool H, which has remained permanently inundated since construction.
 - Attracts wood frogs, spotted salamanders, and spotted turtles.
 - Completion of the breeding cycle (emergence) within the pool has not been confirmed.
 - The presence of green frogs, and the occasional bullfrog, may limit success in pool H.
- 6 constructed pools have not attracted target species, or allowed for complete larval development, over the 10-year monitoring period. Inappropriate hydroperiods are the sole reason for their inability to provide habitat.

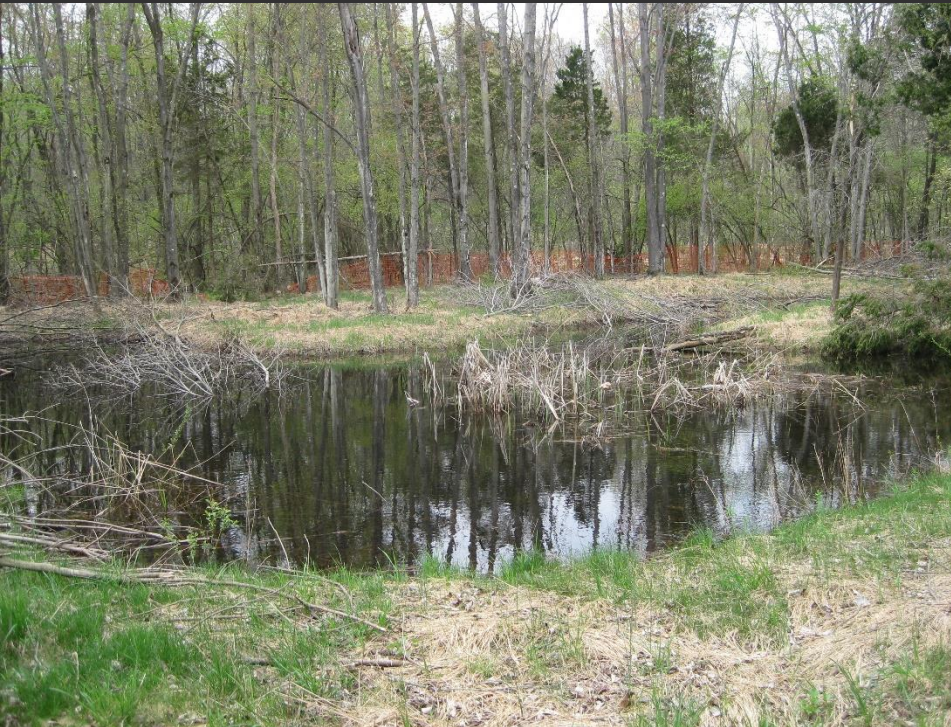
2010

Vernal Pool W

- Percent canopy cover at the vernal pool sites ranges from 5 to 90 percent with eight pools having 50% or less canopy coverage in mid-summer.
- Common native species growing in pools include *Carex* species, *Persicaria* species, broadleaf cattail (*Typha latifolia*), sensitive fern (*Onoclea sensibilis*), and woolgrass (*Scirpus cyperinus*).
- Percent coverage of invasive species:
 - Phragmites australis* – exceeds 5% coverage in 7 pools
(≥25% coverage in 6 pools)
 - Microstegium vimineum* – exceeds 5% coverage in 8 pools
 - Lythrum salicaria* – exceeds 5% coverage in 1 pool

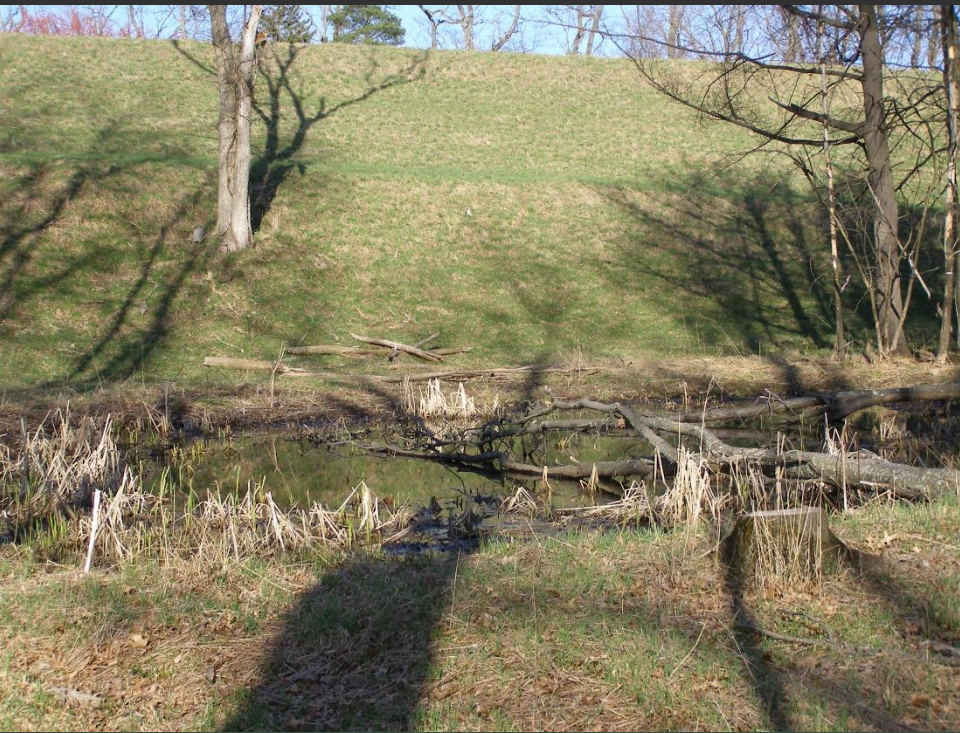
2008

Vernal Pool U

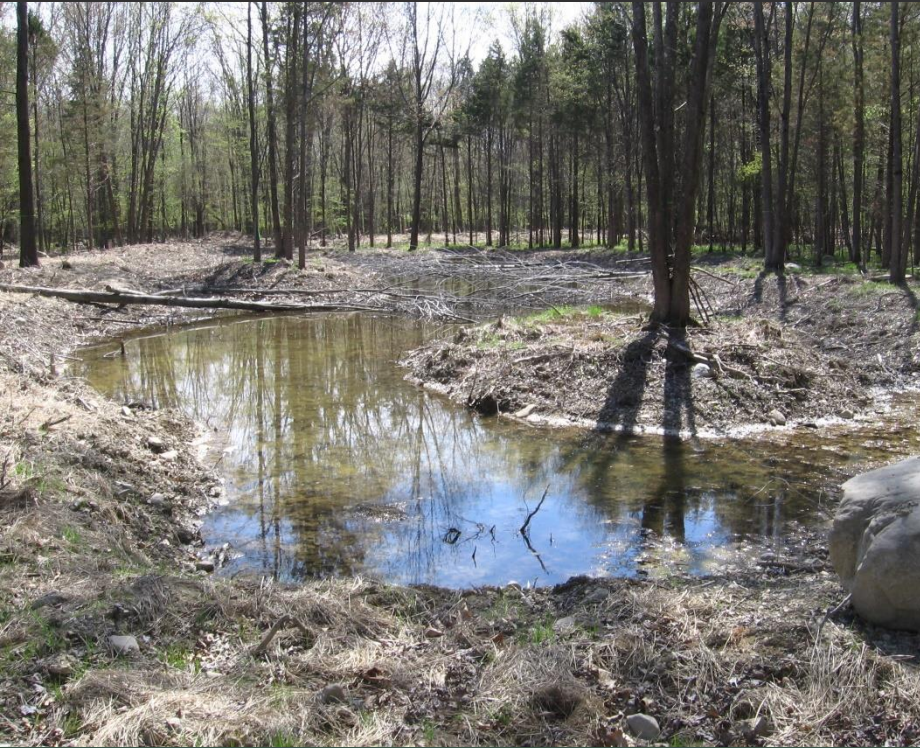
2007

Vernal Pool Z

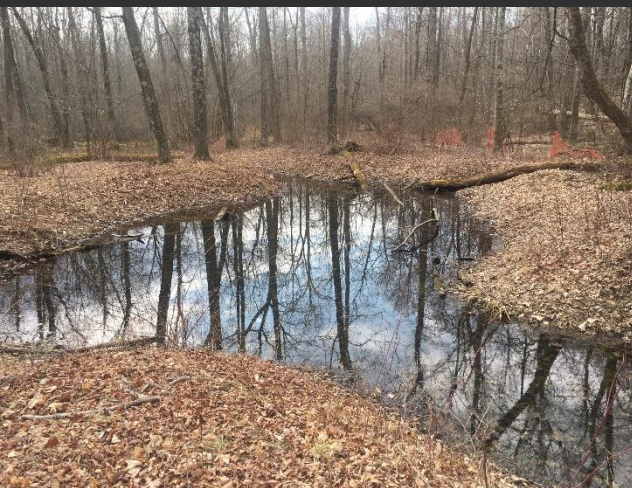
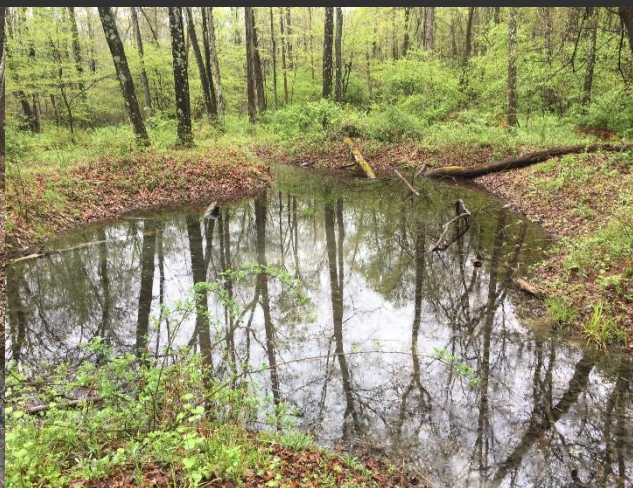
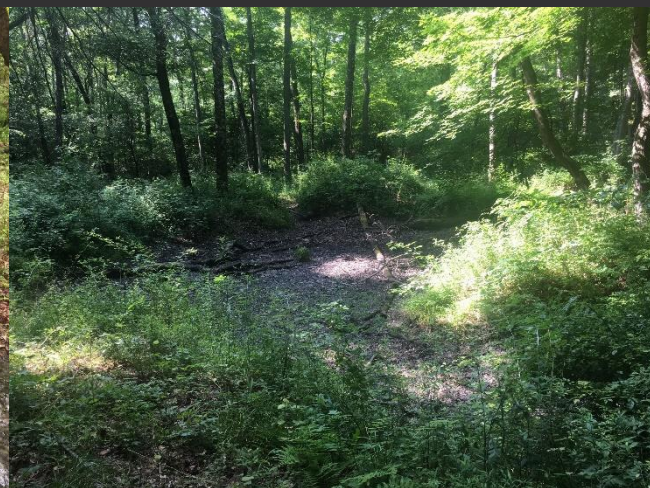
- Pool elevations properly excavated and meet design specifications.
- The depth of the pools are ideal for their surrounding watershed and meet the target hydroperiod.
- Pools hold water long enough for metamorphosis and dry out to limit predators.
- Invasive species have not encroached and reduced functionality of the pools
- Closed canopy mimics that of natural vernal pools

Pool B, March

Pool B, May

Pool B, July

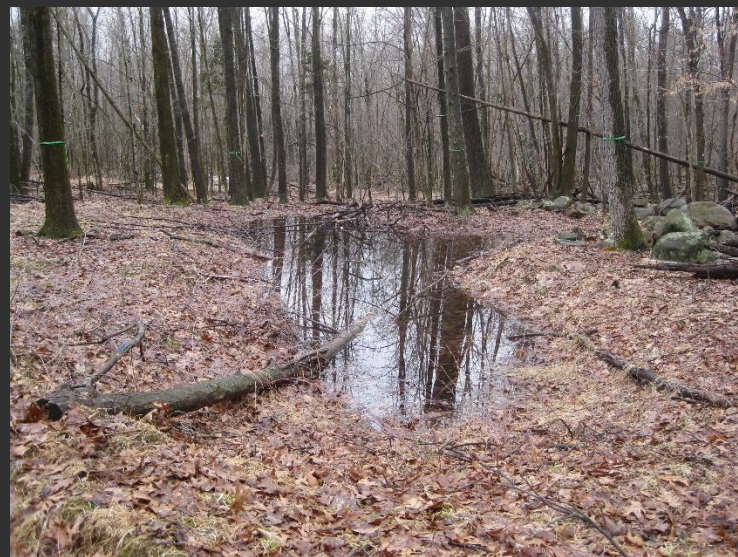
Pool Y, March 2010

- Improper pool elevations
too shallow or too deep
- Improper installation of bentonite layer
- Introduction of invasive species from
construction vehicles and local sources

- Plan for long term invasive species management
- Continuous construction oversight at critical stages such as grading and low permeability layer installation
- Better topographic mapping
- Flexibility in site selection
- Reference Site
- Better defined success criteria
- Realistic Goals

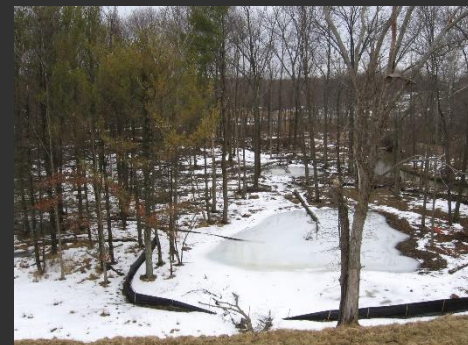
Pool U, January 2007

- Open canopy likely resulted in higher evaporation rates, and excess vegetation growth.
 - Changed available area and water budget.
- Open canopy has contributed to establishment of invasive vegetation.
