BH-FRM Coastal Flood Exceedance Probabilities
Central Artery and Tunnel System
2070 High / 2100 Intermediate High Scenarios
3.2 feet (98 cm) SLR relative to 2013

**BH-FRM Coastal Flood Exceedance Probabilities
Central Artery and Tunnel System
2030 High Scenario
0.62 feet (19 cm) SLR relative to 2013**

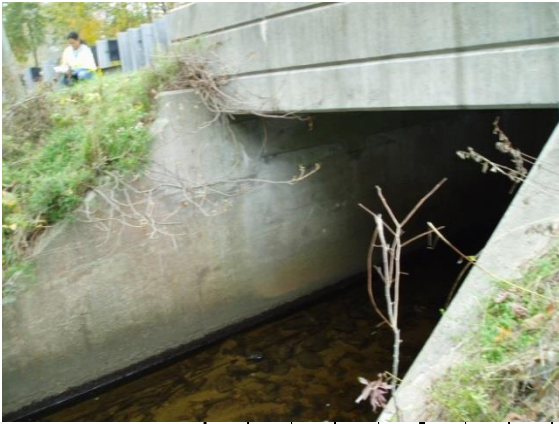
STRUCTURE NO. 02315 HEADWATER DEPTH VS. PEAK DISCHARGE

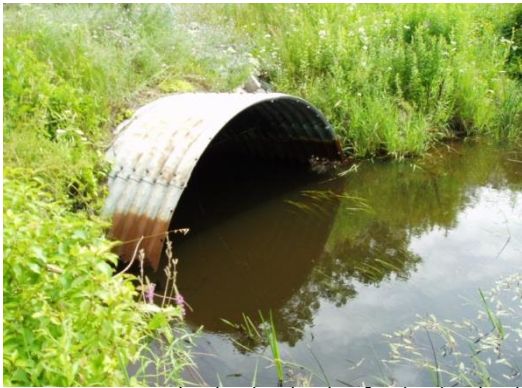
STRUCTURE NO. 05417
HEADWATER DEPTH VS. PEAK DISCHARGE
