# The Geomorphic-Engineering Approach to Designing Bridges and Culverts

**Roy Schiff**

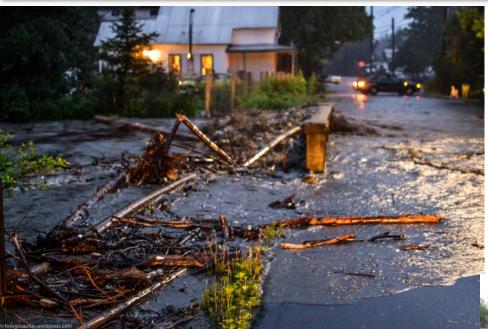
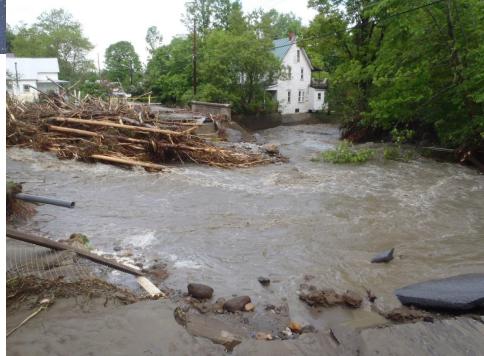
# Large Wood at Bridges

Great Brook Brook Road in Plainfield, VT 7/19/2015 Photo taken by B. Towbin

Great Brook Brook Road in Plainfield, VT 5/27/2011 Photo taken by G. Springston

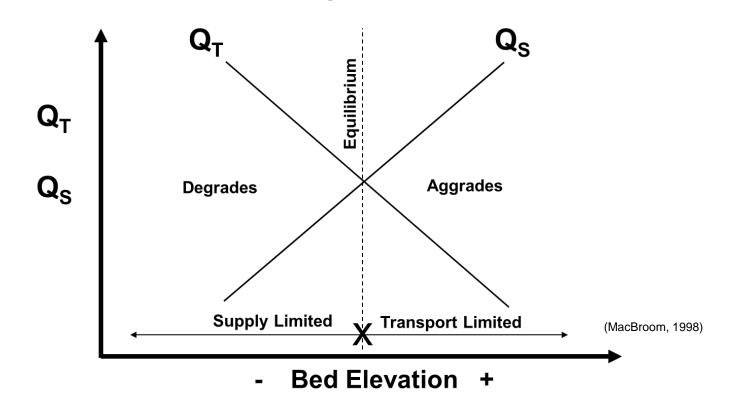
### Sediment Transport

- Equilibrium: Load ≅ Transport
- Deposition: Supply > Transport
- Erosion: Transport > Supply
- Local Scour: Bridges, bends, contractions

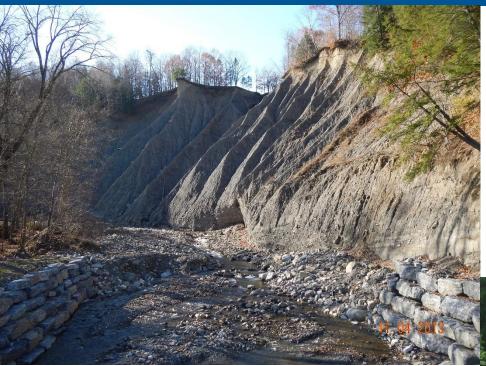
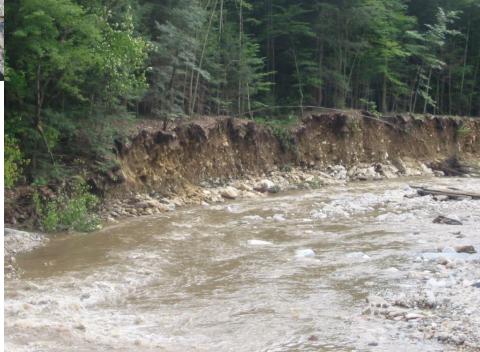
# **Identify Sediment Sources**

Fulmer Creek German Flatts, NY (M. Carabetta, 2013)

Roaring Branch Bennington, VT (MMI, 2011)

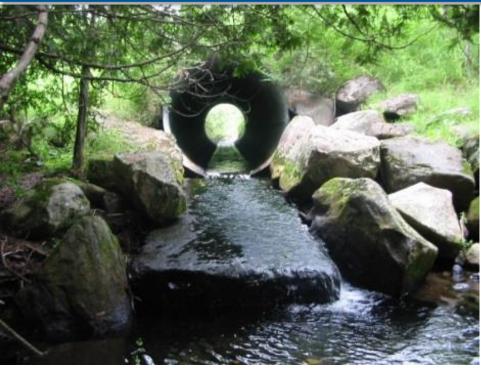
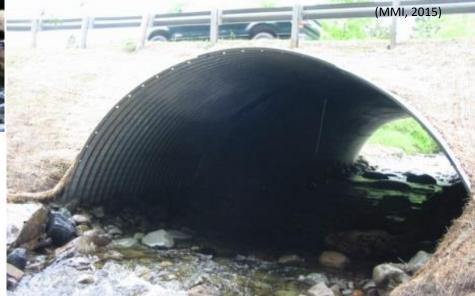
Former culvert

New culvert→

HIGH RESILIENCY = HIGH CONNECTIVITY

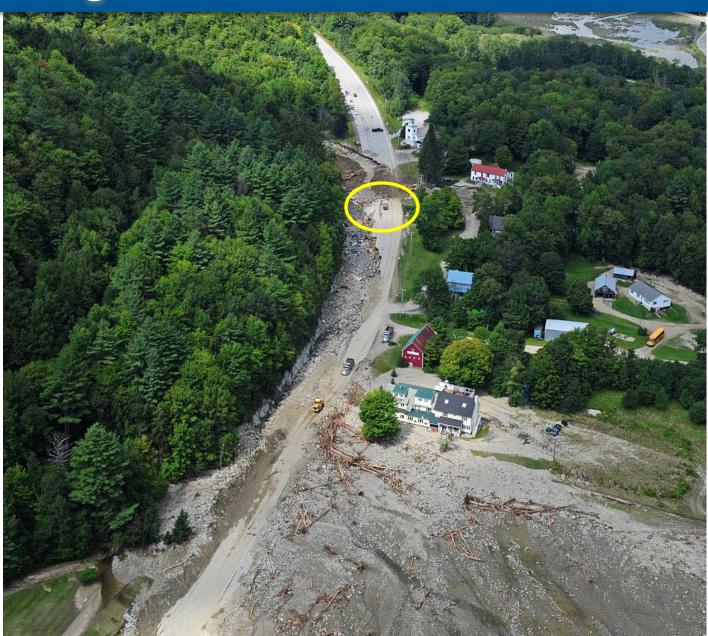
# Poor Bridge Alignment

Roaring Brook US Route 4 in Killington, VT Photo by Lars Gange & Mansfield Heliflight, August 31, 2011)
