ASSESSING WILDLIFE MOVEMENT POTENTIAL WITHIN THE CLOCA JURISDICTION

Northeastern Transportation and Wildlife Conference September 12, 2016

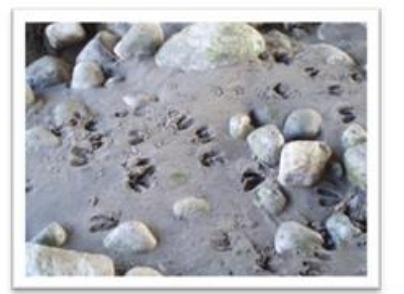
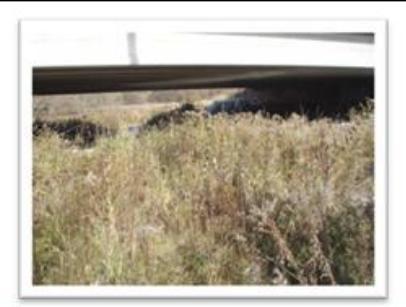
BACKGROUND			INFRASTRUCTURE					
Evaluator:	J. Scott	2	Watercourse?	Yes			194	
Date:	11/17/11		Culvert/Bridge?	Yes - Bridge	Height (h):	4 m	Width (w):	26.5 m
Time:	11:12 am		Road Width (I):	22.5 m	Lanes:	4	Sidewalk?	No
Watershed:	Lynde Creek				Paved/Gravel?	Paved	Shoulder?	Curb
Location:	Zone 17				Speed:	80 km/h	No. cars/5 min	86
	661878 m E	4863733 m N	Openness Ratio (h x w / I):		4.71

WILDLIFE						
Adjacent Habitat:	Cattail marsh surrounded by deciduous forest to the north. Meadow with some cedar trees on the edges to the south.					
Terrestrial Passage?	Yes Present on both sides of watercourse. Cobble, gravel, and sand.					
Evidence of Use?	Yes Tracks in sand.					
Evidence of Roadkill?	Yes 2 raccoons and 1 bird (Northern Flicker).

Рнот	OS
52:	Animal tracks under the bridge
53:	Bridge, taken from south side.

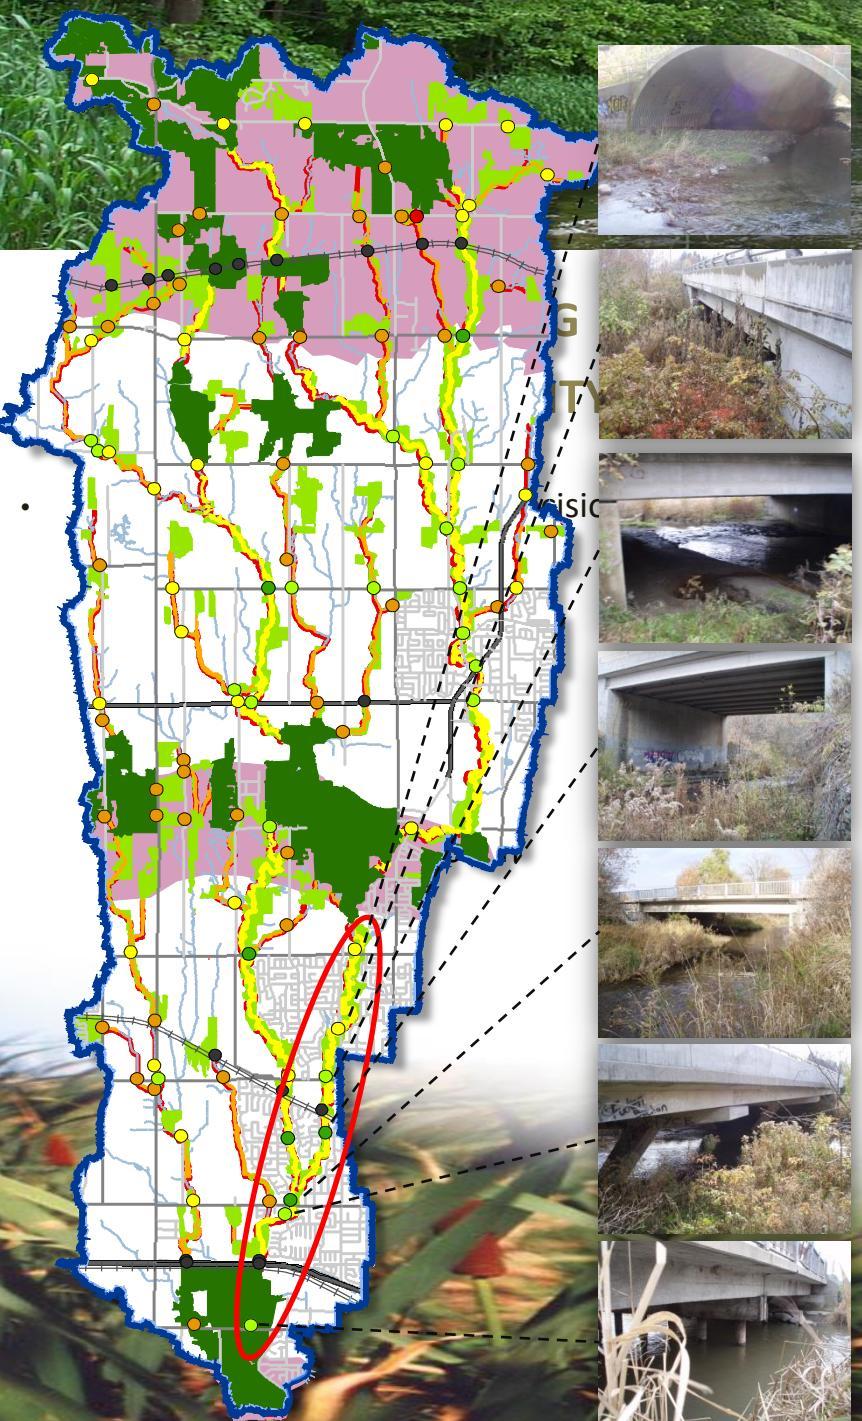
CRITERIA	VALUE		
 Culvert height ≥ 3.0 m OR ≥ 0.6 	EXCELLENT		
Terrain is present along entire length of culvert/bridge	(suitable for all wildlife)		
• Culvert height \geq 1.0 m

• OR ≥ 0.25	(suitable for small mammals		
Terrain is present along entire length of culvert/bridge	and reptiles)		
• Culvert height \geq 1.0 m			
• OR ≥ 0.1

• Terrain is present along entire length of culvert/bridge	(suitable for small mammals only)		
• Culvert height \geq 0.5 m	MODERATE 🔶		
• OR ≥ 0.25	(suitable for reptiles and

• Terrain may or may not be present	amphibians only)		
• Any breaks in the habitat network that do not			
meet the above 4 criteria, but where the barrier is a gravel road with a traffic volume < 3 cars/5 min	(low risk of mortality from cars)

• Any breaks in the habitat network where a culvert	POOR		
exists, but does not meet the criteria in first 5 categories	(not suitable for most wildlife)

• Any breaks in the habitat network that do not	VERY POOR		
meet the criteria in any of the categories listed above and where there is no culvert	(mobile wildlife at highest risk of being hit on road)
